# STATE OF NEW YORK DEPARTMENT OF HEALTH

## FATALITY ASSESSMENT AND CONTROL EVALUATION

### Machine Operator Dies of Crushing Injuries When Caught by a Bridle Roller on a Hot Tin Coating Line Case Report: 02NY026

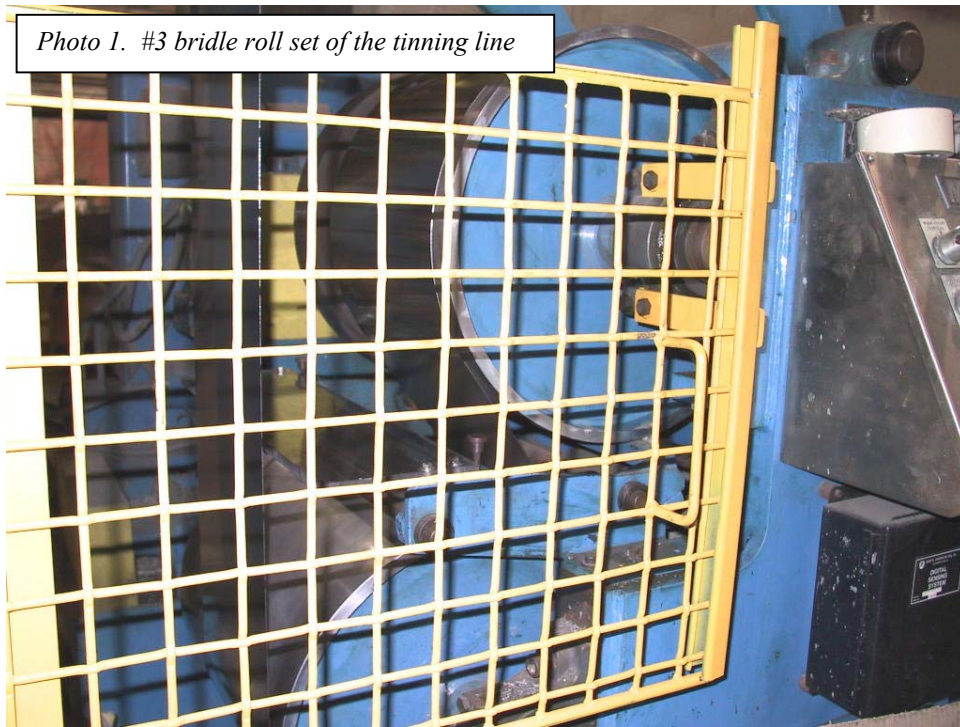
On the tinning line that was involved in the incident, brass or copper alloy strips were coated with tin to prevent oxidation of the metals. The machine was designed and built in the plant by the employer five years prior to the incident. The main components of the tinning line included a payoff block, a cleaning chamber, a flux chamber, a drying chamber, a tinning bath, a windup block, a set of turning rollers, and three (#1, #2 and #3) sets of bridle rollers. A metal coil strip was loaded onto the payoff block; it then was cleaned, etched, and tinned before it was wound into a coil on the windup block as the finished product. The function of the steel bridle rollers, which were 22 inches in diameter and 24 inches in length, was to hold line tension (Photo 1). The line tension was normally kept at approximately 1000 pounds per square inch (psi) on the metal strip. The tinning

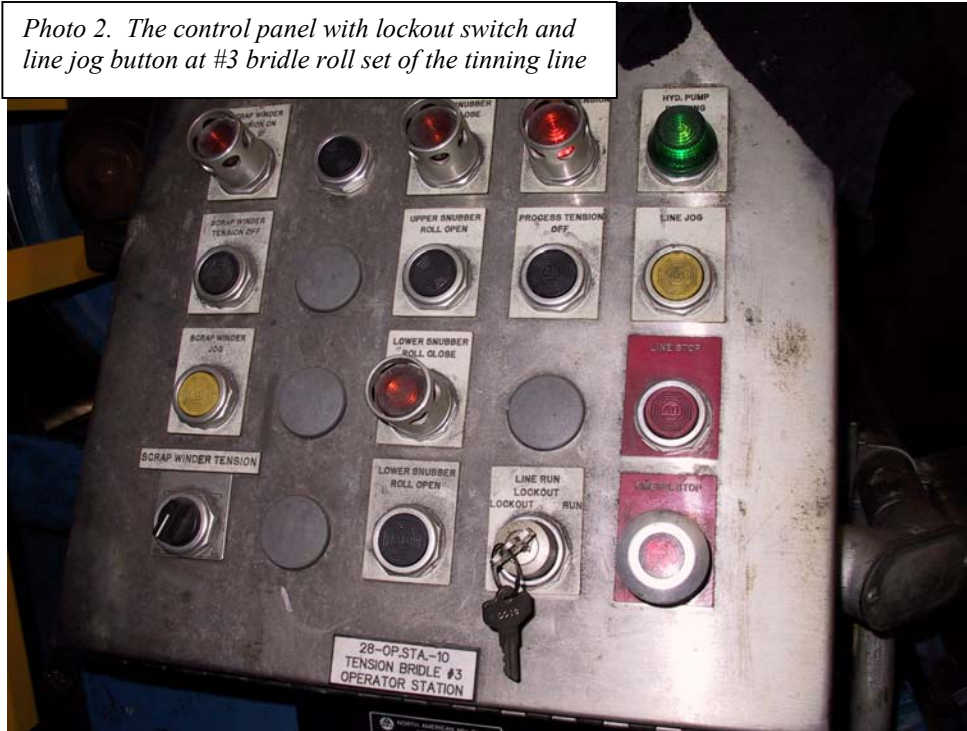
After the tinning bath, the metal strip went around two turning rollers and the #3 bridle roll set, prior to reaching the windup block. Debris from the newly coated strip adhered to the surface of these rollers, potentially causing dents (defects) on a strip. Thus, these rollers had to be cleaned by the line operators before a new strip was loaded, which was approximately two to three times per shift. According to the management of the company, the line operators were trained to follow a standard procedure when cleaning the rollers. The procedure required that the operator stop the line by setting it to lockout mode before beginning the cleaning process (Photo 2). Setting the line to lockout mode prevented other personnel from starting the line from other control panels. According to company management, after the line was stopped, the operator was supposed to use a wire brush with a three-foot long handle to scrub and clean the surface of the rollers. During cleaning, the operator could rotate the rollers slightly by pushing a jog button, which was a “deadman” control; i.e., the line moved only when the button was held down against spring tension. The bridle roller cleaning procedure was not in writing and the tinning line “Break In Manual” did not have specific provisions on how to clean the bridle rollers.

*Photo 2. The control panel with lockout switch and line jog button at #3 bridle roll set of the tinning line*

**Recommendation #1:** *Train and closely supervise employees in standard machinery cleaning procedures and strictly enforce adherence to these procedures. This should include ensuring that workers are protected from the unexpected release of hazardous energy by enforcing lockout/tagout procedures (OSHA regulation 29 CFR 1910.147-Control of Hazardous Energy [lockout/tagout]).*

Operator's manuals should have clear written instructions on how to perform roller cleaning tasks. Operators should be trained to strictly follow standard cleaning procedures and employers should enforce the requirement for locking out the line when cleaning the rollers. Scheduled and unscheduled safety inspections may be conducted by a competent person to ensure that workers follow standard roller cleaning procedures.

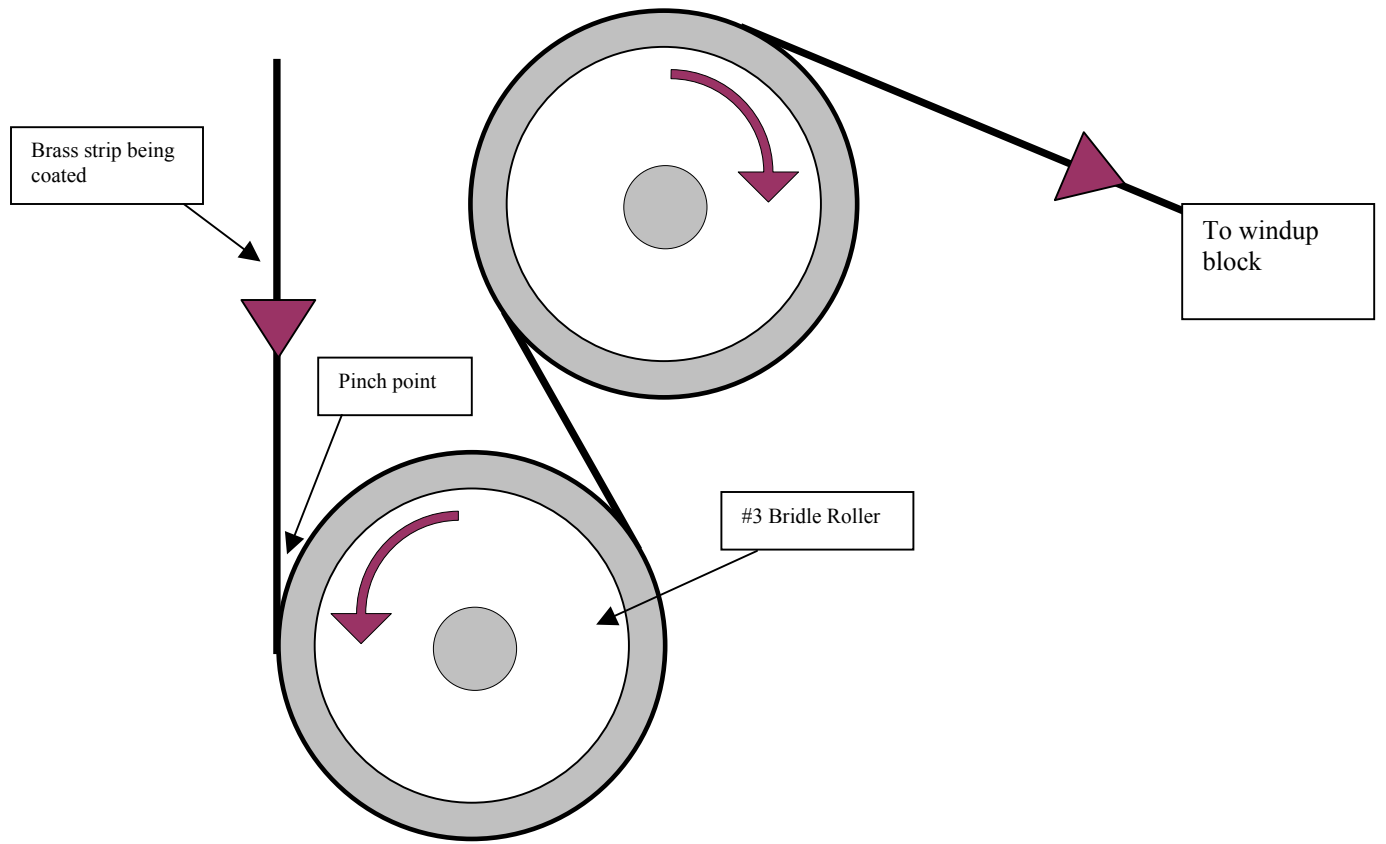
The incident occurred on May 13th during the second shift and was not witnessed by the other line operator. At the time of the incident, a new 6.25 inch wide brass strip had just been loaded onto the machine and the line was running at a speed of 50 FPM. A post-incident investigation done by the company revealed that the standard roller cleaning procedure was not followed by some operators, including the victim. Instead of stopping and locking out the line prior to cleaning the rollers with the wire brush, some operators held a piece of sand paper against the rotating rollers with their hands while the line ran at a slow speed of 50 FPM. During the incident, it appeared that the victim's left glove became caught between the #3 bridle roller and the moving brass strip as he was cleaning the bridle roller with the piece of sandpaper (Figure 1). He was pulled into the line and subsequently received crushing injuries to his head. At approximately 8:30 PM, the other second-shift line operator noticed that the brass strip was out of alignment. He followed the strip to the #3 bridle roller and saw the victim, jammed and crushed by the roller and the brass strip. The operator immediately hit the emergency stop button to shut down the line and notified the shift supervisor. The shift supervisor phoned the plant EMT, who arrived at the scene within minutes and extricated the victim. A state police investigator also responded to and secured the site. The medical examiner was called and pronounced the victim dead at the scene.

At the time of the NY FACE site visit, the company had installed a metal grid gate to guard the pinch point of the #3 bridle roller set. The employer had yet to decide whether, and how, to interlock the gate with the tinning line.

**Figure 1. Pinch point created by the moving brass strip and rotating #3 bridle roller**

**Recommendation #2:** *Install machine guards that interlock with the tinning line.*

**Discussion:** It is extremely dangerous to clean the rollers when the tinning line is running. A barrier guard should be installed so workers cannot reach through, over, under or around the guard to come in contact with the pinch point of a roller during normal operation. One way to eliminate human error and ensure that the line stops prior to cleaning is to interlock the barrier guard with the line: when the guard is removed, the line stops; when the cleaning is done and the guard is reinstalled, the line can resume running.
