STATE OF NEW YORK DEPARTMENT OF HEALTH

FATALITY ASSESSMENT AND CONTROL EVALUATION

Mechanic Killed when Aerial Work Platform Collapses Case Report: 07NY080

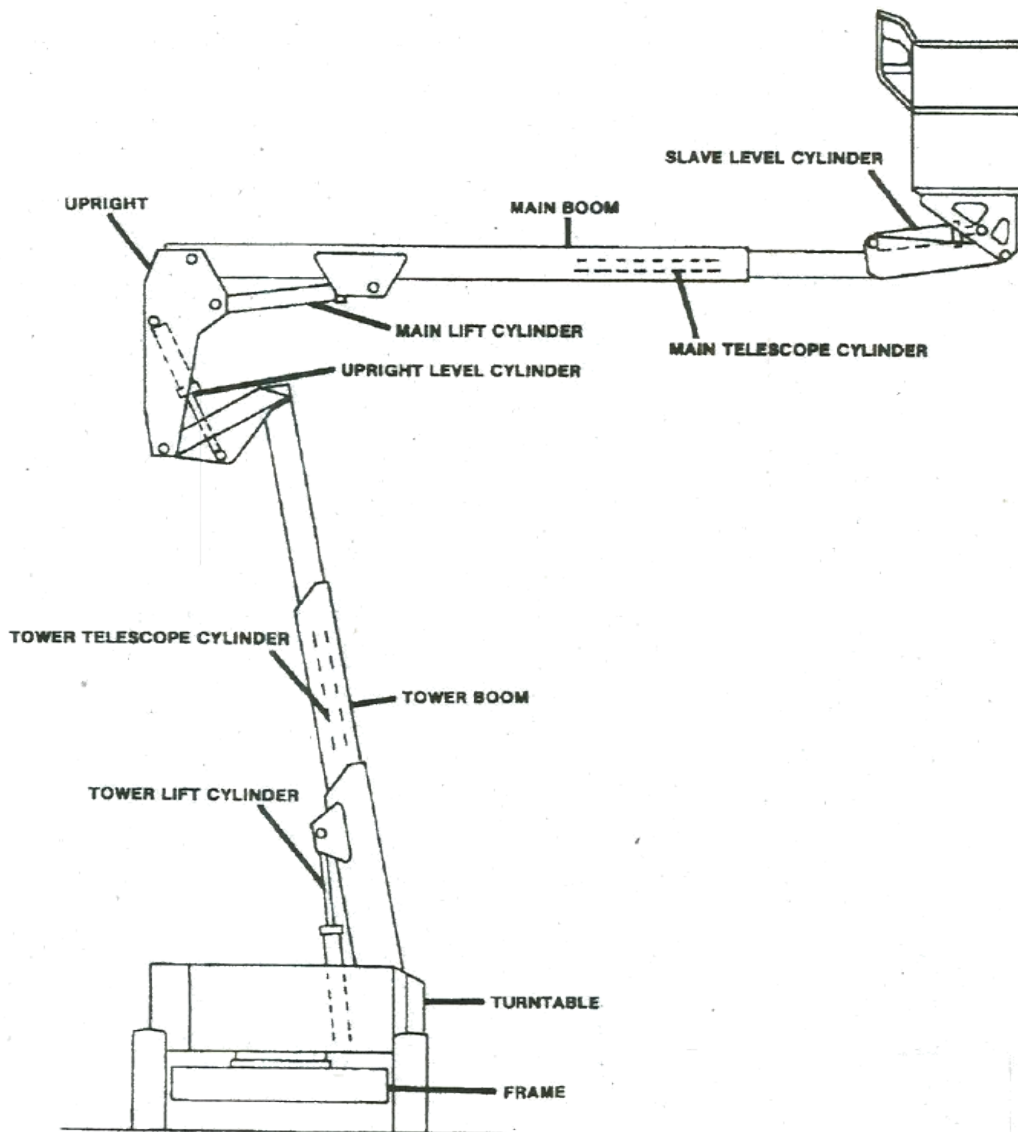
Figure 1. The schematic of the boom-supported aerial work platform.

The collapse of the aerial work platform was determined to be caused by a failure of the upright level cylinder (Figure 1): the rod of the cylinder had broken away from the cylinder barrel (Photo 3). After the incident, a mechanic who specialized in the model and make of the aerial work platform examined the failed cylinder. The mechanic concluded that the rod assembly of the cylinder had been modified and the modification directly caused the failure of the cylinder.

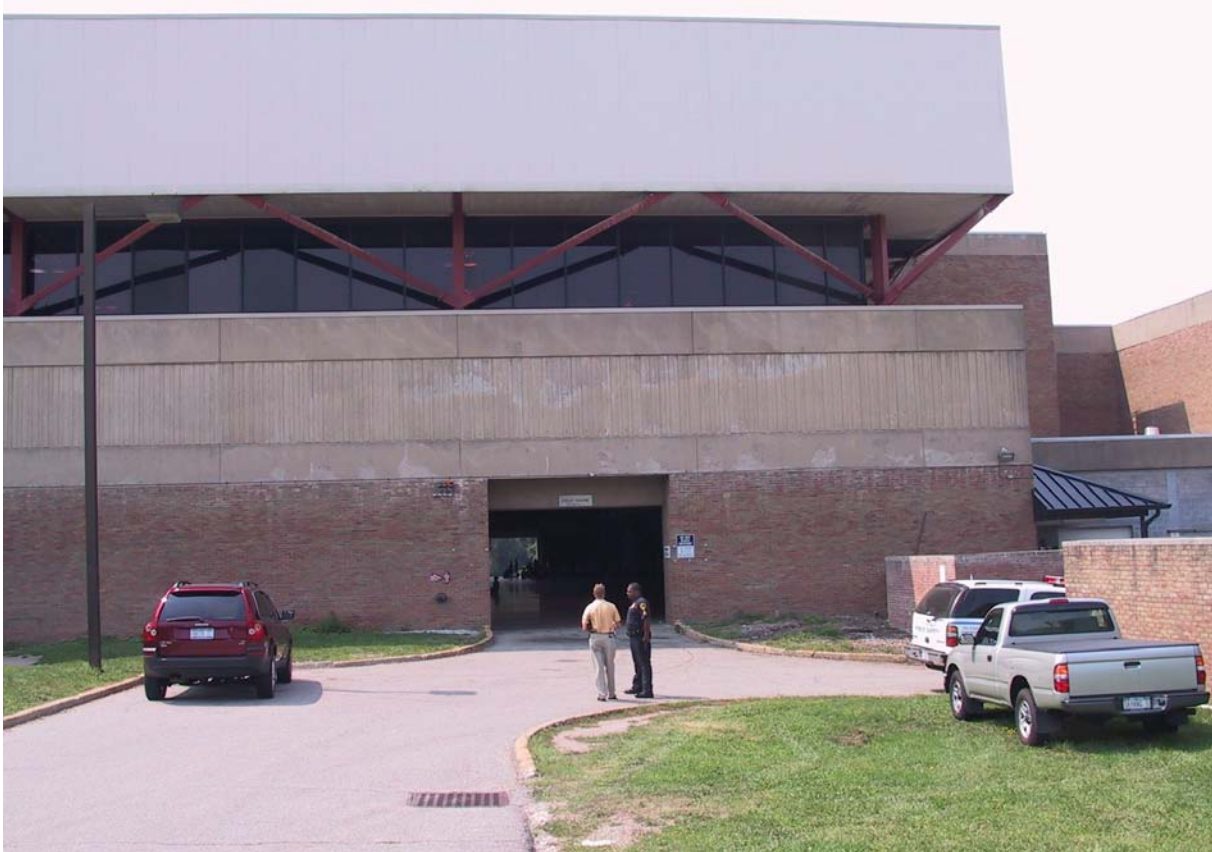
Photo 1. The Field House entrance where the aerial work platform was parked during the incident.

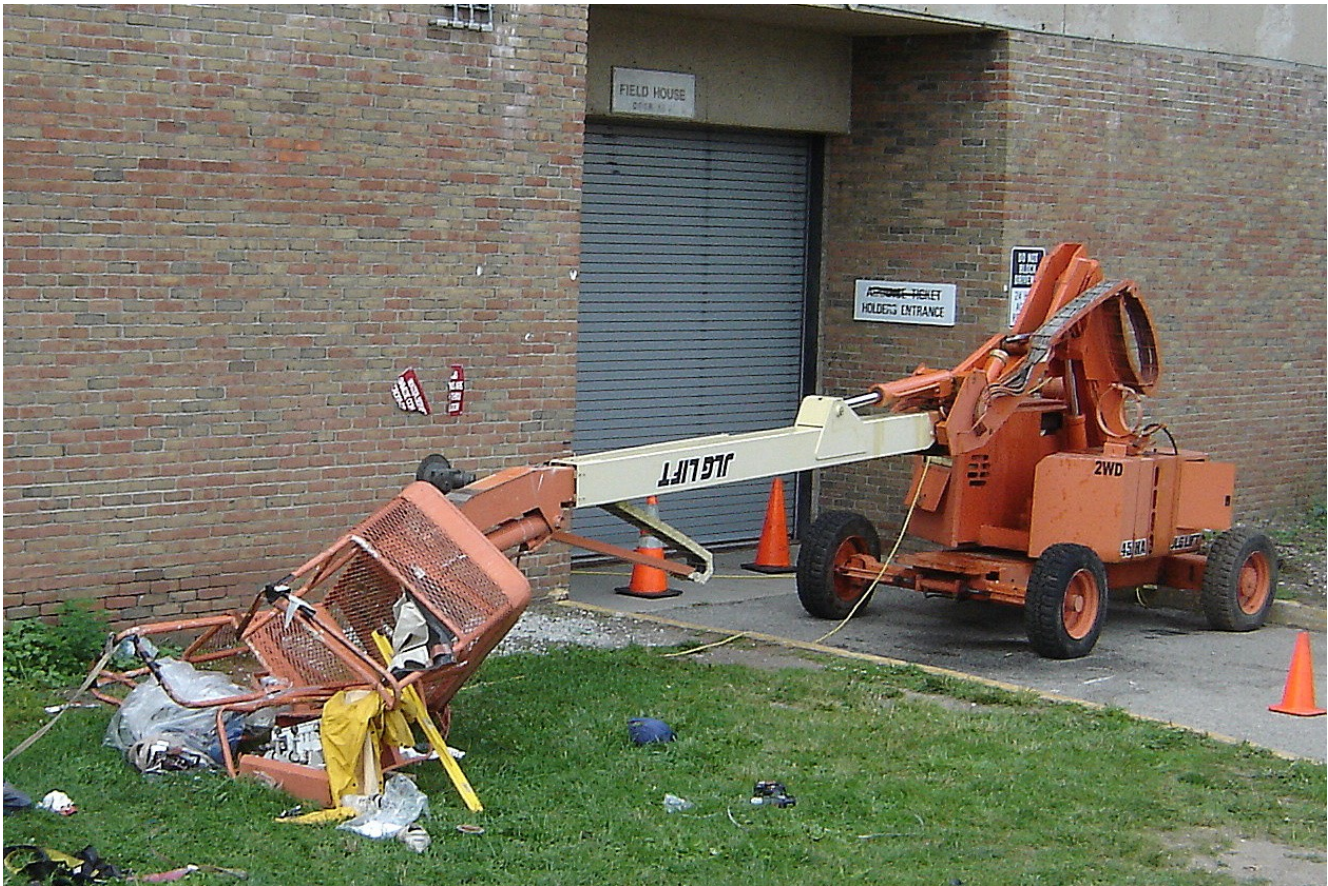
At approximately 11:40 am, the lift basket fell to the ground and landed on the grassy surface (Photo 2). A camp student heard the crashing noise; he came outside and saw the collapsed aerial work platform. The victim was inside the basket and the co-worker was on the grass in front of the basket. Campus security was notified immediately and paramedics arrived within minutes. Both workers were transported to a hospital where the victim died an hour later. The co-worker had serious injuries and survived. Based on measurements taken at the incident site, it was estimated that the victim and the co-worker fell approximately 40 feet.

Photo 2. The aerial work platform collapsed during the incident and the lift basket crashed to the ground and landed on the grassy surface by the Field House (Photo courtesy of OSHA).

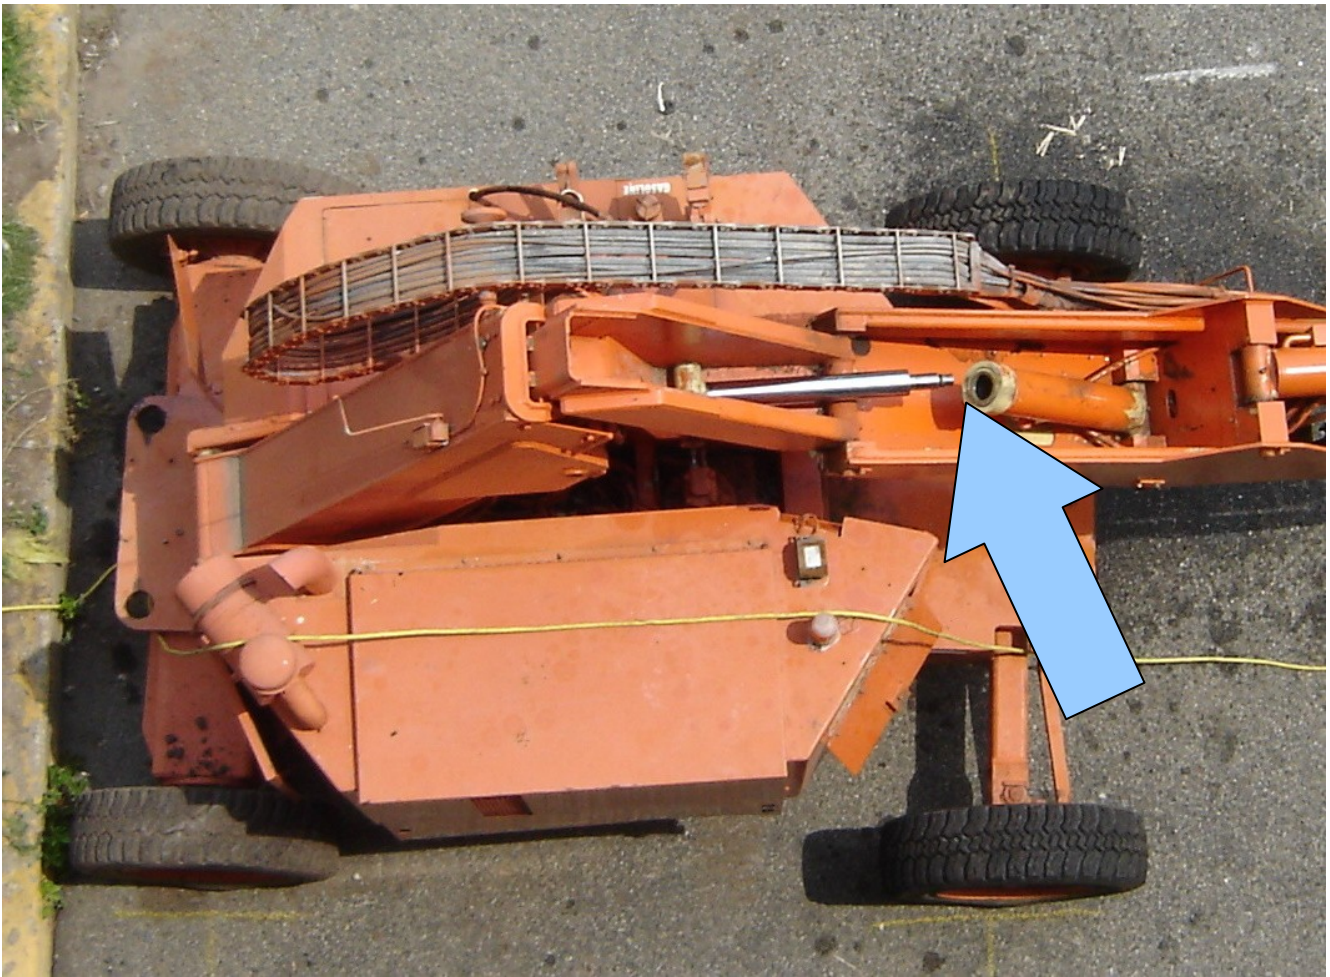
Photo 3. Top view of the collapsed aerial work platform with the rod completely separated from the upright level cylinder (Photo courtesy of OSHA)

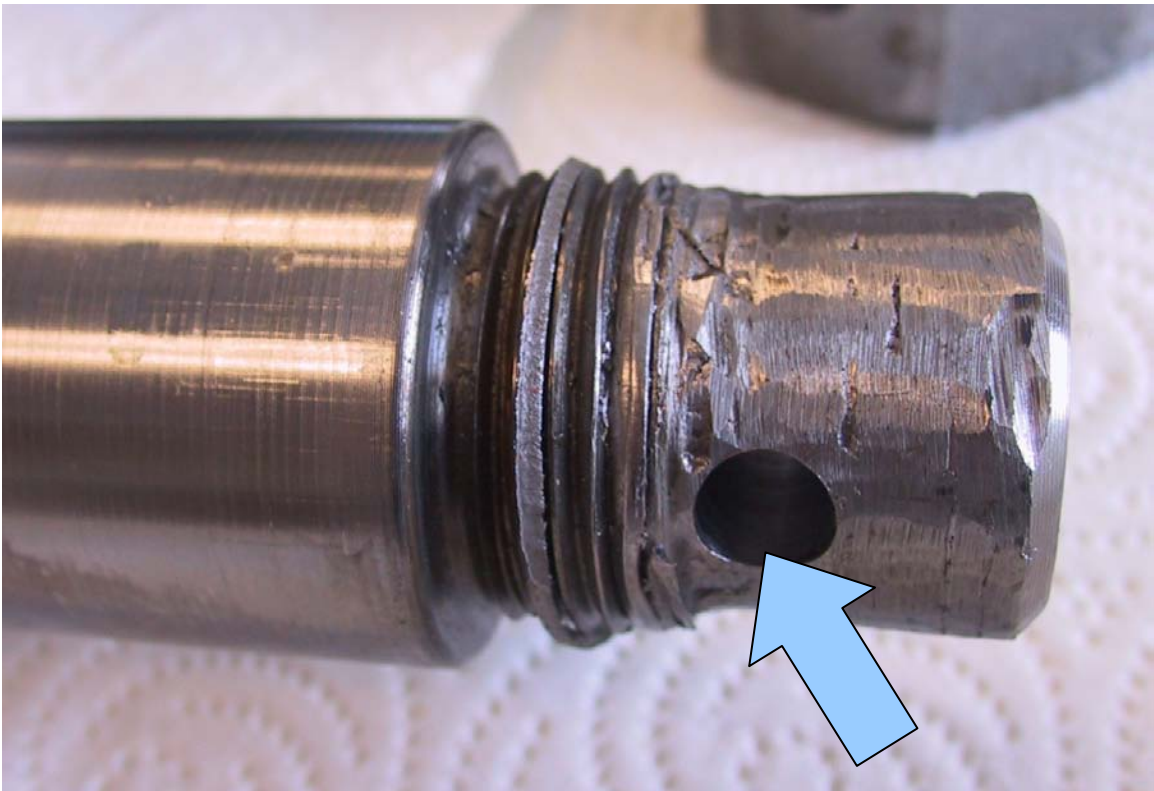
The original rod assembly of the cylinder had a threaded end. The piston was secured to the rod by a hex nut that screwed into the threaded end. The hex nut had a set screw to secure it to the rod. The investigation found that the thread of the rod assembly of the failed cylinder was ground off. A hole was drilled through the hex nut and the rod (Photo 4 and Photo 5). A bolt had been inserted through the hex nut and the rod and it was fastened with a nut. The bolt broke into three pieces (Photo 6) during the incident and caused the cylinder to fail.

Photo 4. The thread of the failed cylinder rod was ground off and a hole had been drilled through the rod.

Recommendation #1: *Owners of aerial work platforms should prohibit unauthorized modifications or alterations of the machines.*

Discussion: Modification or alteration of aerial work platform parts or components may compromise the integrity of the machine and cause serious or fatal injuries. The serious and potentially life threatening consequences of unauthorized modification of aerial work platform parts or structure should be clearly communicated to all employees, including both operators and maintenance staff.

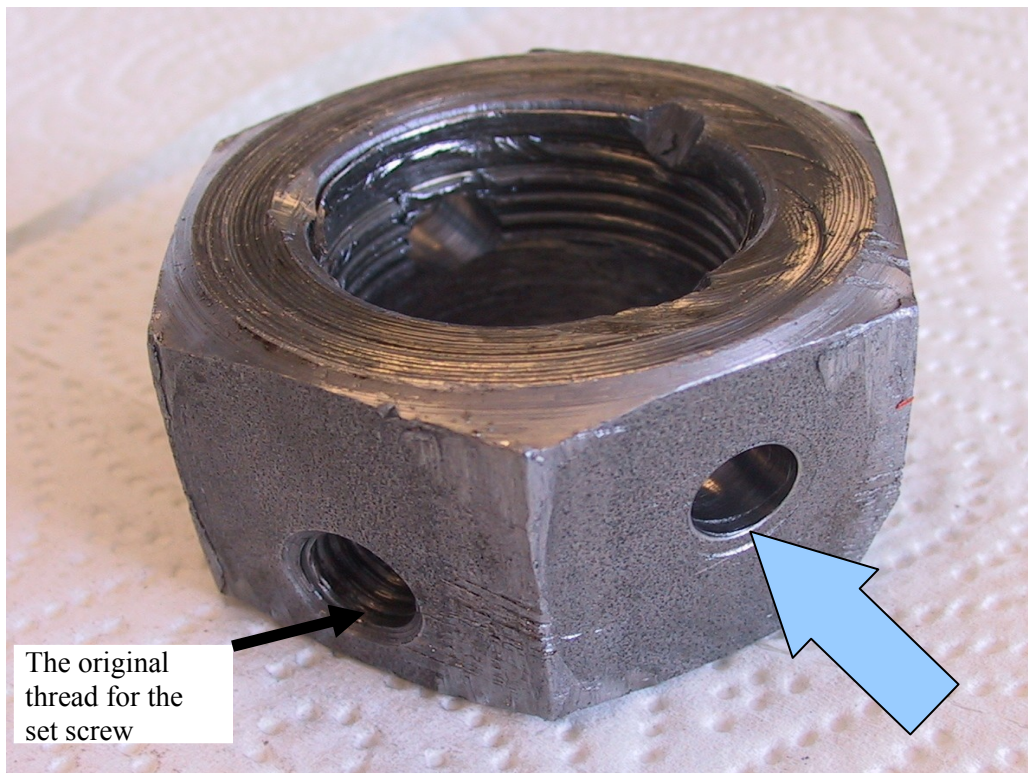
Photo 5. The hex nut was drilled through so that a bolt can be inserted to hold the rod and the nut together.

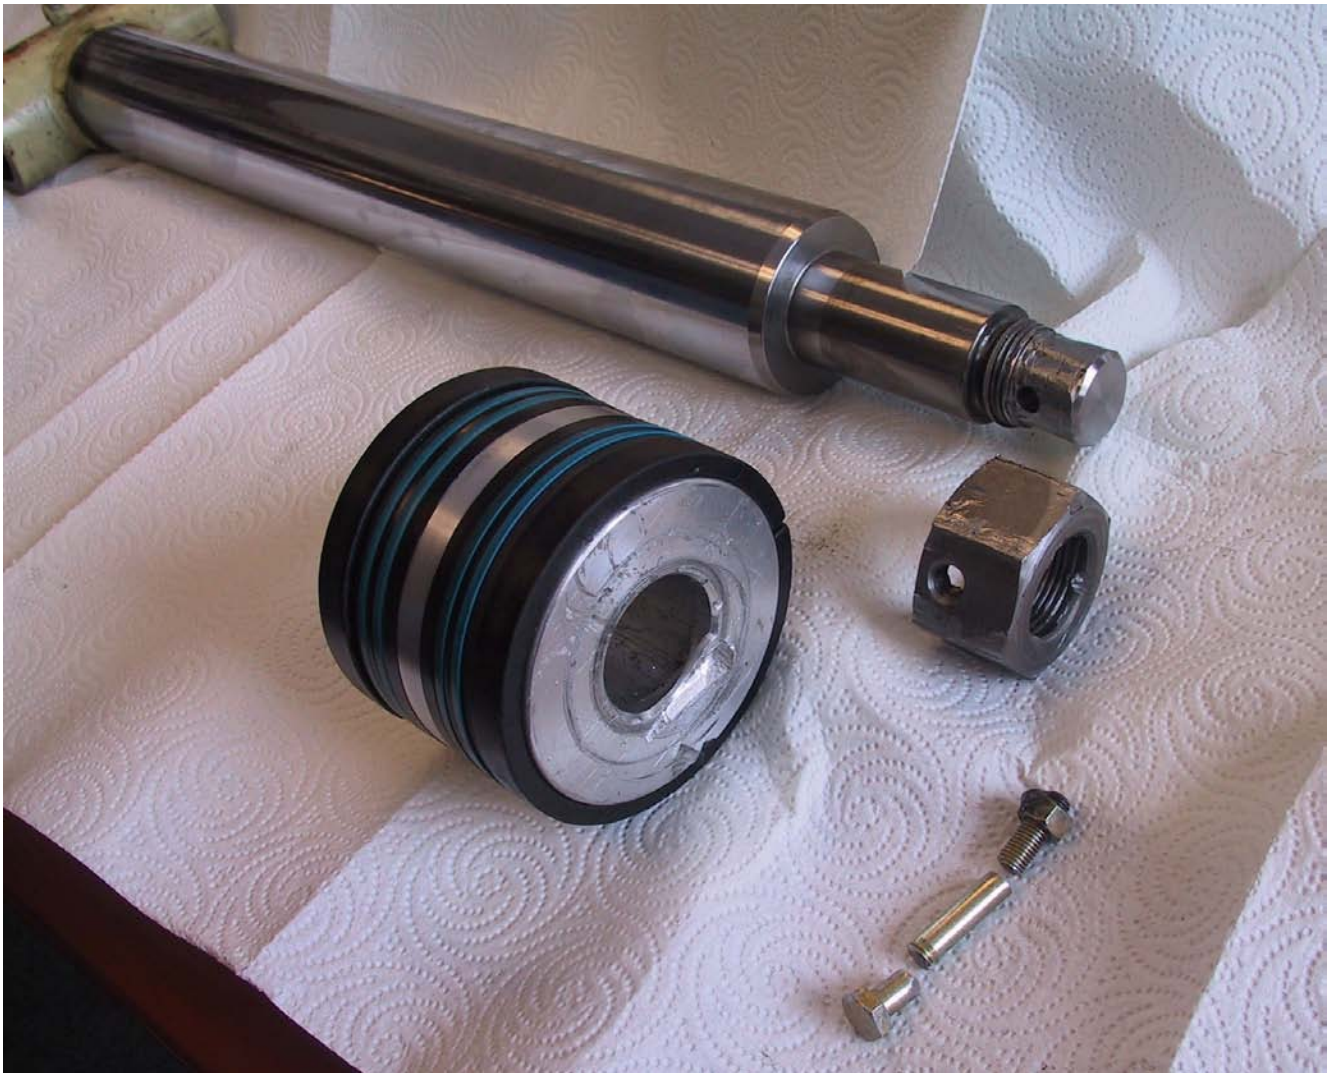
Photo 6. A bolt had been inserted through the hex nut and the rod and it was fastened with a nut. The bolt broke into three pieces during the incident and caused the cylinder to fail.
