## FATALITY ASSESSMENT AND CONTROL EVALUATION

### **Flatbed Truck Starts on Its Own, Crushing Auto Body Shop Worker Case Report 14NY013**

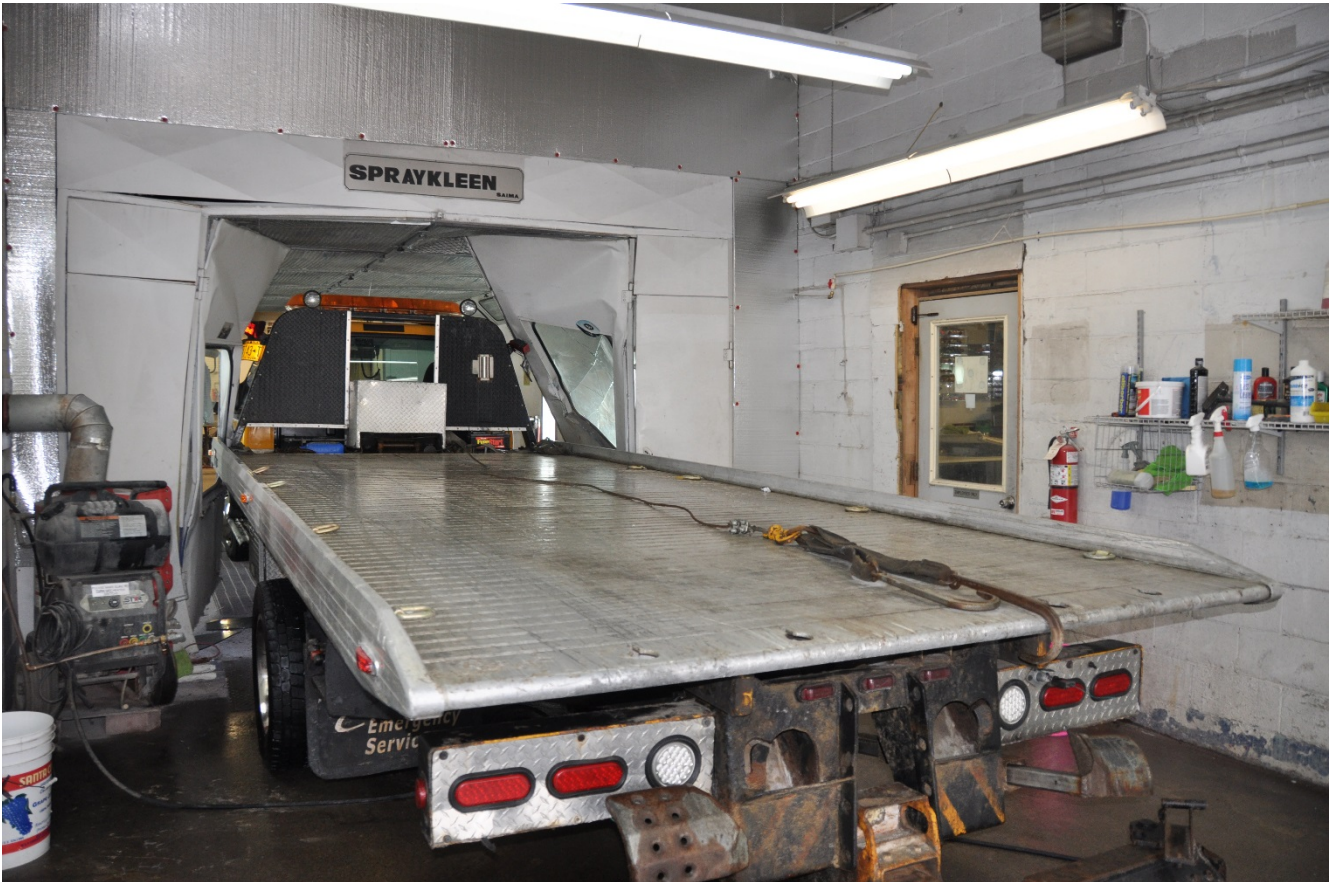
*Photo 1. The Ford 550 Super Duty truck suddenly rolled forward 16 feet and crashed into the paint booth when the victim was cleaning the truck in the wash bay (photo courtesy of OSHA).*

At approximately 11:00 am, a shop technician came into the wash bay through the garage door and saw the truck was rolling forward. The technician yelled to alert others. The truck rolled 16 feet into the paint booth and stopped, smashing the paint booth door and pushing it open backwards into the paint booth. The victim was pinned and crushed between the paint booth door and the passenger side of the truck. There were six other employees on site that day. One worker called 911. The other workers pulled the paint booth door away from the victim and freed him. The emergency medical technicians (EMTs) arrived within minutes. The victim was transported to a hospital where he died from crushing injuries.

**Recommendation #1:** *Employers should ensure that workers always set parking brakes and chock the wheels when working on or around a vehicle.*

**Discussion:** The flatbed truck spontaneously started and moved forward due to an improperly installed starter. To prevent injury, workers should always set the parking brakes and chock the wheels before working on or around a vehicle. Employees should include this requirement in the company safety standard procedure and provide worker training and supervision to ensure compliance.

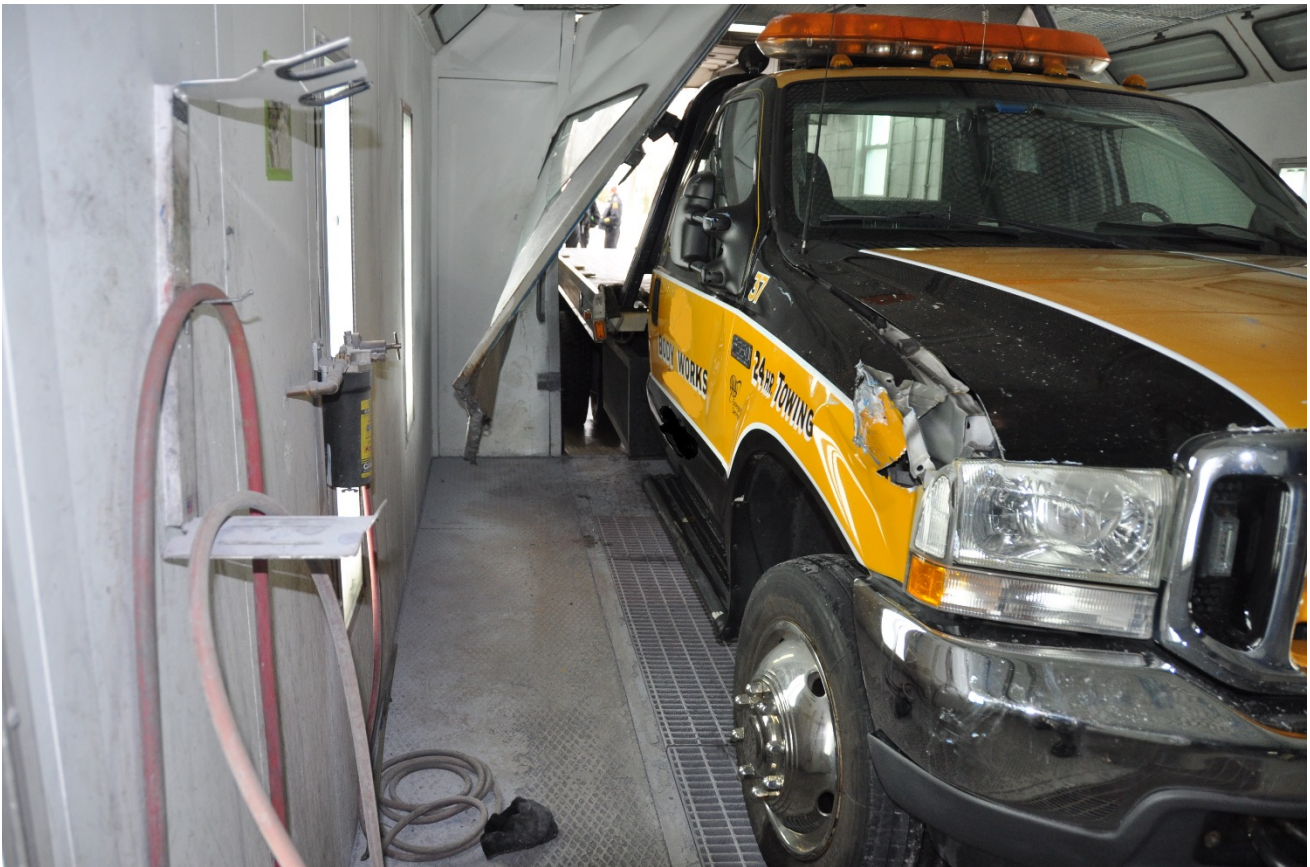
*Photo 2. The victim was crushed and pinned between the paint booth door and the passenger side of the truck (photo courtesy of OSHA).*

**Recommendation #3:** *Emergency response staff should set the parking brake, chock the wheels, and disconnect the main battery cable to prevent movement of a vehicle when responding to a vehicle emergency.*

**Discussion:** The short circuit between the battery cable and the signal wire in this case caused the truck to lurch forward. When responding to a vehicle-related call, emergency response staff should always set parking brake, chock the wheels, and disconnect the battery cable to prevent accidental start or movement of the vehicle. The EMTs in this case did not take these prevention measures.

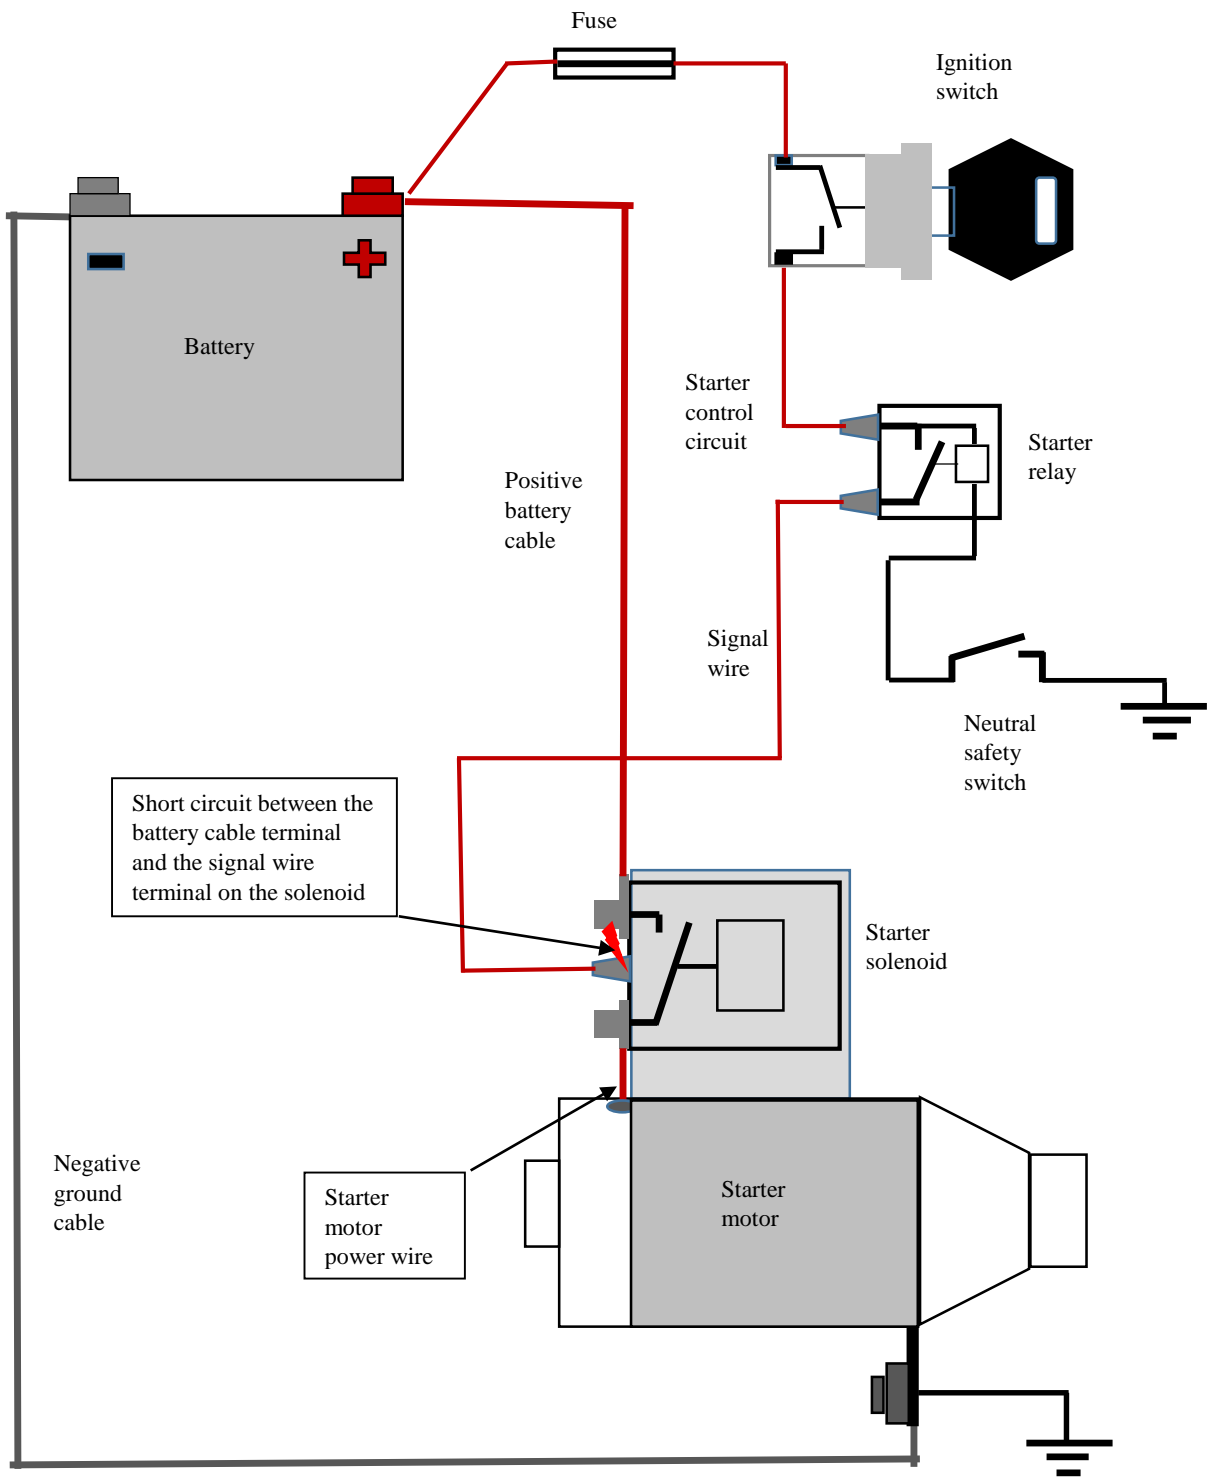
After the incident, a Ford certified mechanic from a local Ford dealer examined the truck's starter system and found a short circuit on the solenoid. Figure 1 illustrates a typical automobile starting system that consists of a battery, an ignition switch, a starter relay, a neutral safety switch, a starter solenoid, and a starter motor. When the ignition key is turned to the "start" position, the battery voltage goes through the starter control circuit and activates the starter solenoid. The starter solenoid works as an electric switch: when activated, it closes the circuit and connects the starter motor to the battery and the starter motor cranks the engine and starts the vehicle. As indicated in Figure 1, the short circuit occurred between the battery cable terminal and the signal wire terminal on the solenoid.

Figure 1. Diagram of a car starting system (Courtesy of Samarins.com)

The mechanic also found that the neutral safety switch on the truck was broken. A neutral switch is a device for preventing accidental or unintentional starting of a vehicle. It is installed at the automatic transmission shifter mechanism, or at the clutch pedal for manual transmission (Figure 1). A vehicle can only be started when the ignition key is turned to START position and the automatic transmission shifter is in “Park” or “Neutral” position, or when the clutch pedal is depressed if the vehicle has a manual transmission, as in this case. The broken neutral safety switch did not contribute to the spontaneous start of the truck since the starter control circuit including the neutral safety switch was bypassed due to the short circuit on the solenoid.

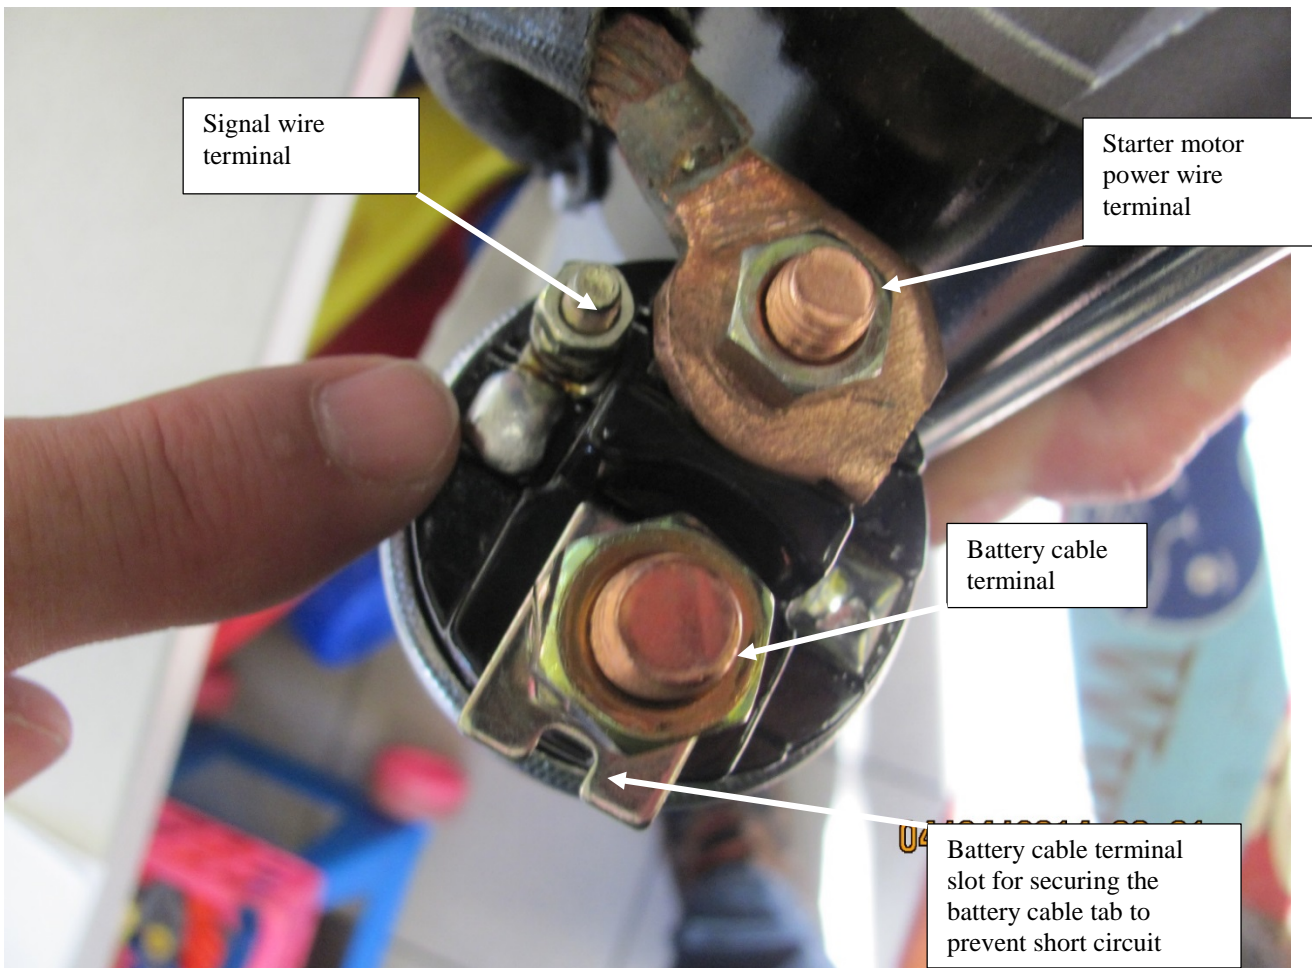
There are three terminals on the starter solenoid of a Ford 550 Super Duty truck: the battery cable, the signal wire, and the starter motor terminals (Photo 3). The battery cable connects the solenoid to the positive terminal of the battery. The signal wire connects the solenoid with the starter control circuit composed of ignition switch, starter relay, and neutral safety switch. The battery cable should be secured to prevent it from contacting with any part of the signal wire or the starter motor power wire.

*Photo 3. Terminals on a new Ford 550 Super Duty truck solenoid. The battery cable tab should be secured into the slot to prevent it from contacting the other two terminals (photo courtesy of OSHA).*

**Recommendation #4:** *Manufacturers should consider modifying the design of solenoid terminals to prevent a short circuit between the terminals.*

**Discussion:** The three terminals on the Ford 550 Super Duty starter solenoid were in close proximity to each other. Manufacturers should consider modifying the design to prevent the battery cable from contacting the signal wire. An insulation barrier could be installed between the terminals to prevent a short circuit.

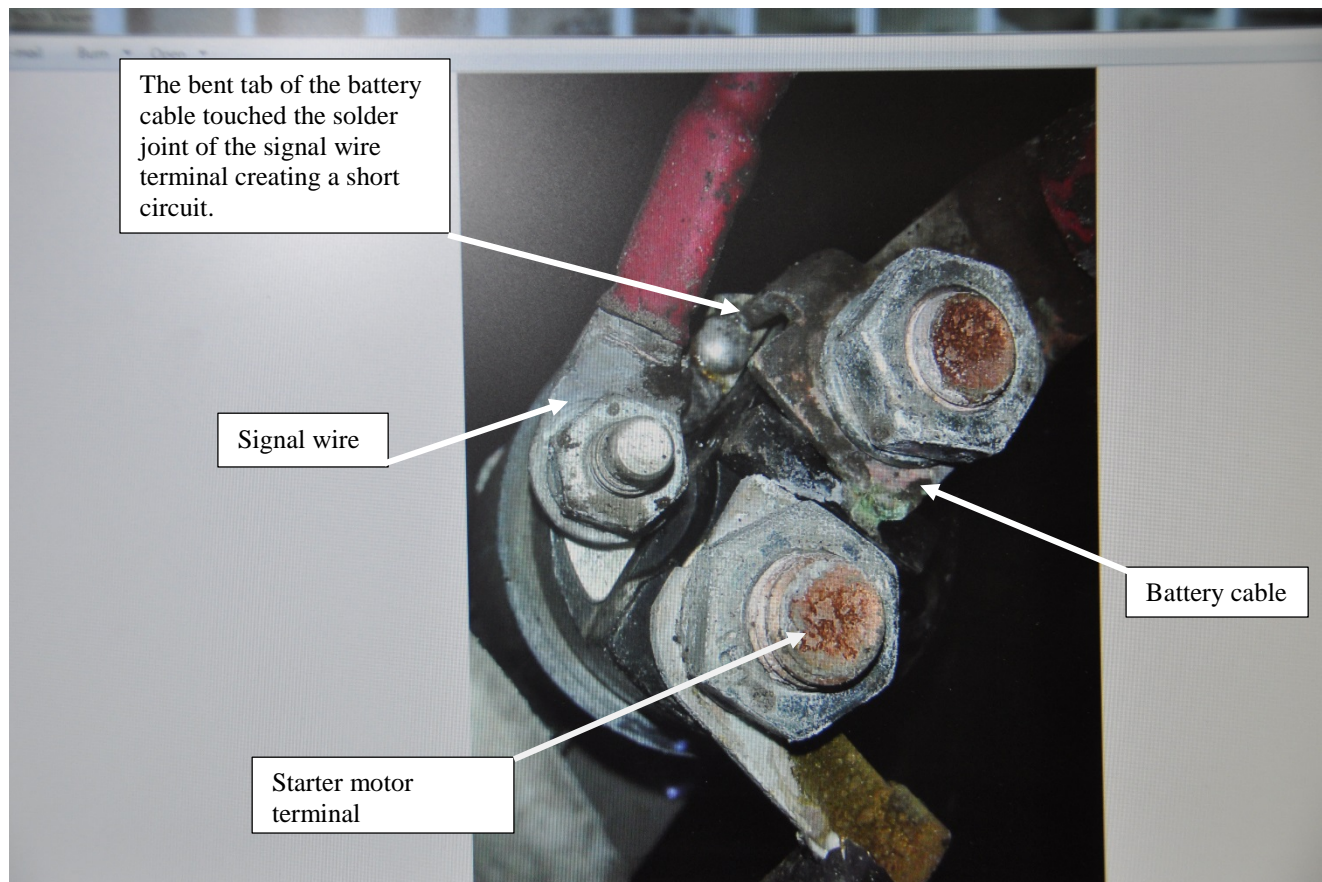
Photo 4 shows how the cables were connected to the solenoid of the flatbed truck that was involved in the incident. There was a tab that was bent at a 90 degree angle on the truck's battery cable (Photo 4). In order to prevent a short circuit, the tab should be securely placed into the slot on the battery terminal (see "battery cable terminal slot" in Photo 3). As it is shown in photo 4, the battery cable tab was not placed in the battery cable terminal slot. Instead, it was 90 degrees counterclockwise from its designed position. The bent tab was in close proximity to a raised solder point of the signal wire terminal. The battery cable was not tightened and it could be wiggled by hand. The Ford certified mechanic noticed that the starter motor was hot which indicated that the starter motor was getting power from the battery even when the truck was not running. He concluded that the likely cause of the spontaneous starting of the truck was the short circuit on the solenoid.

*Photo 4. Three terminals (battery cable terminal, signal wire terminal, and starter motor power wire terminal) on the Ford 550 Super Duty truck solenoid and the cables connected to them. The tab of the battery cable contacted the solder joint of the signal wire creating a short circuit (photo courtesy of OSHA).*

The starter unit was located under the passenger side door. While the victim was cleaning the passenger side with the pressure washer, the bent tab on the battery cable likely contacted the soldered point on the signal wire terminal. The short circuit sent the battery power to energize the starter motor that caused the truck, which was in First gear, to lurch forward and crush the victim.

**Recommendation #2:** *Employers should ensure that employees take extra precautions to insure that starters are installed properly according to the manufacturer's specifications.*

**Discussion:** In this case, the tab of the battery cable was not secured in the slot on the solenoid battery terminal to prevent it from contacting the signal wire. When installing a starter, extra precautions should be taken to ensure that the battery cable is properly installed to prevent a short circuit. Employers should ensure that all parts are installed strictly following the manufacturer's requirement.
