INCIDENT HIGHLIGHTS

REPORT#: 15NY032

REPORT DATE: 04/19/22

Construction Worker Fatally Struck by Steel Sheet Pile Falling from a Vibratory Pile Driver

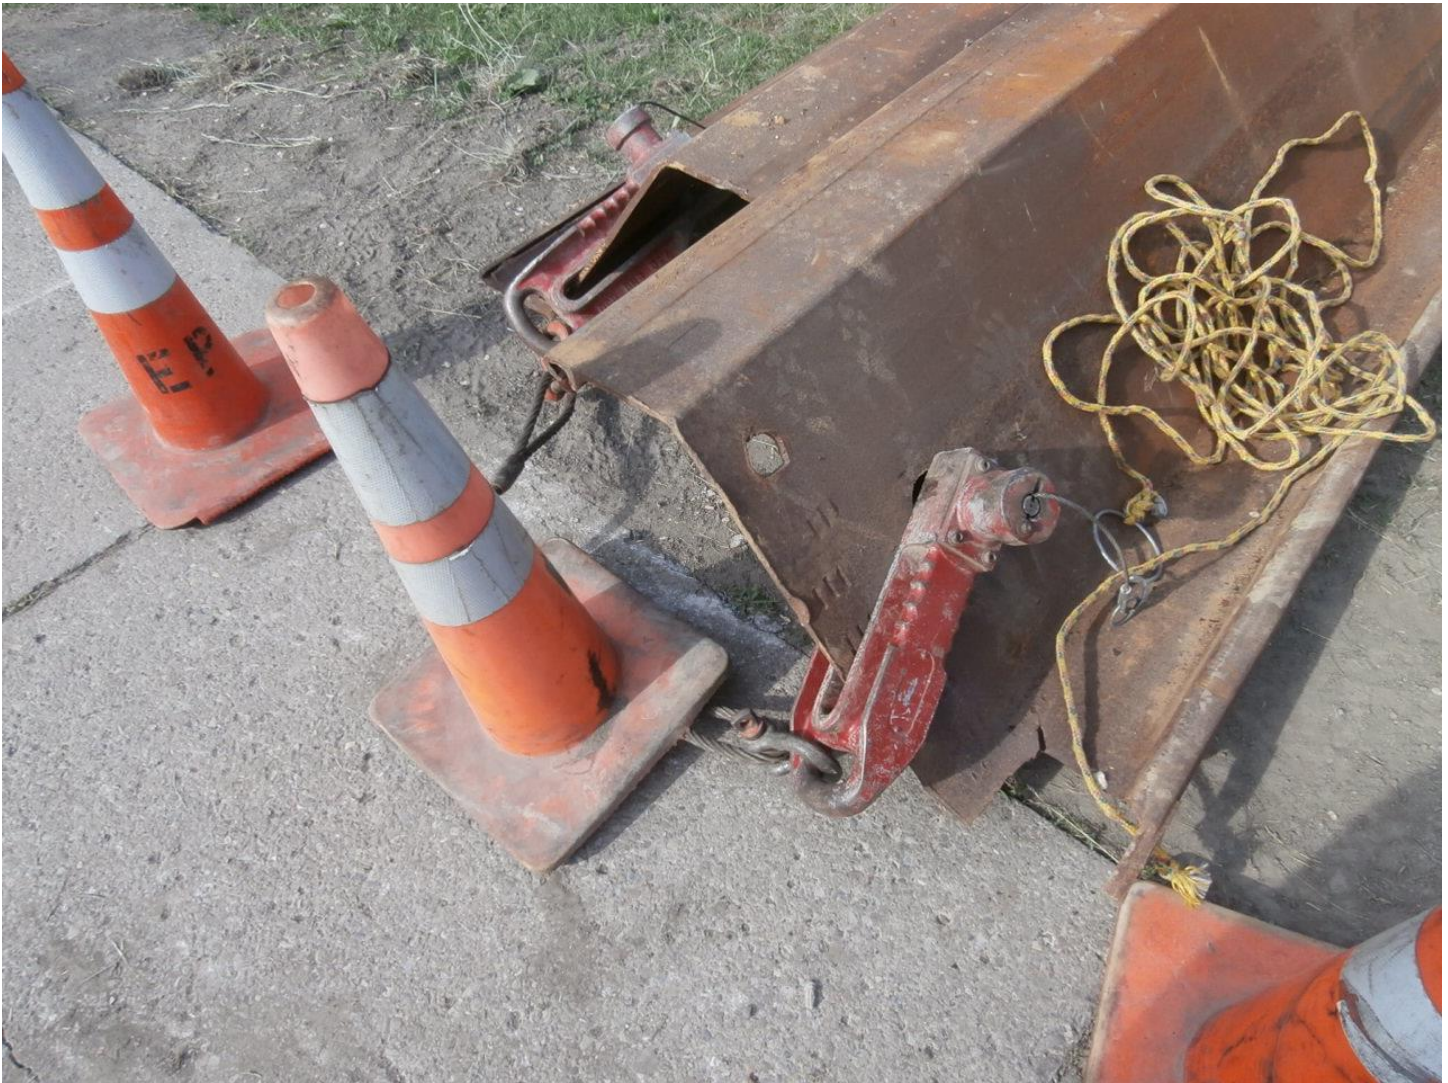
Photo 5. Pile shackles with ground release attached to a pair of sheet pile (photo courtesy of OSHA).

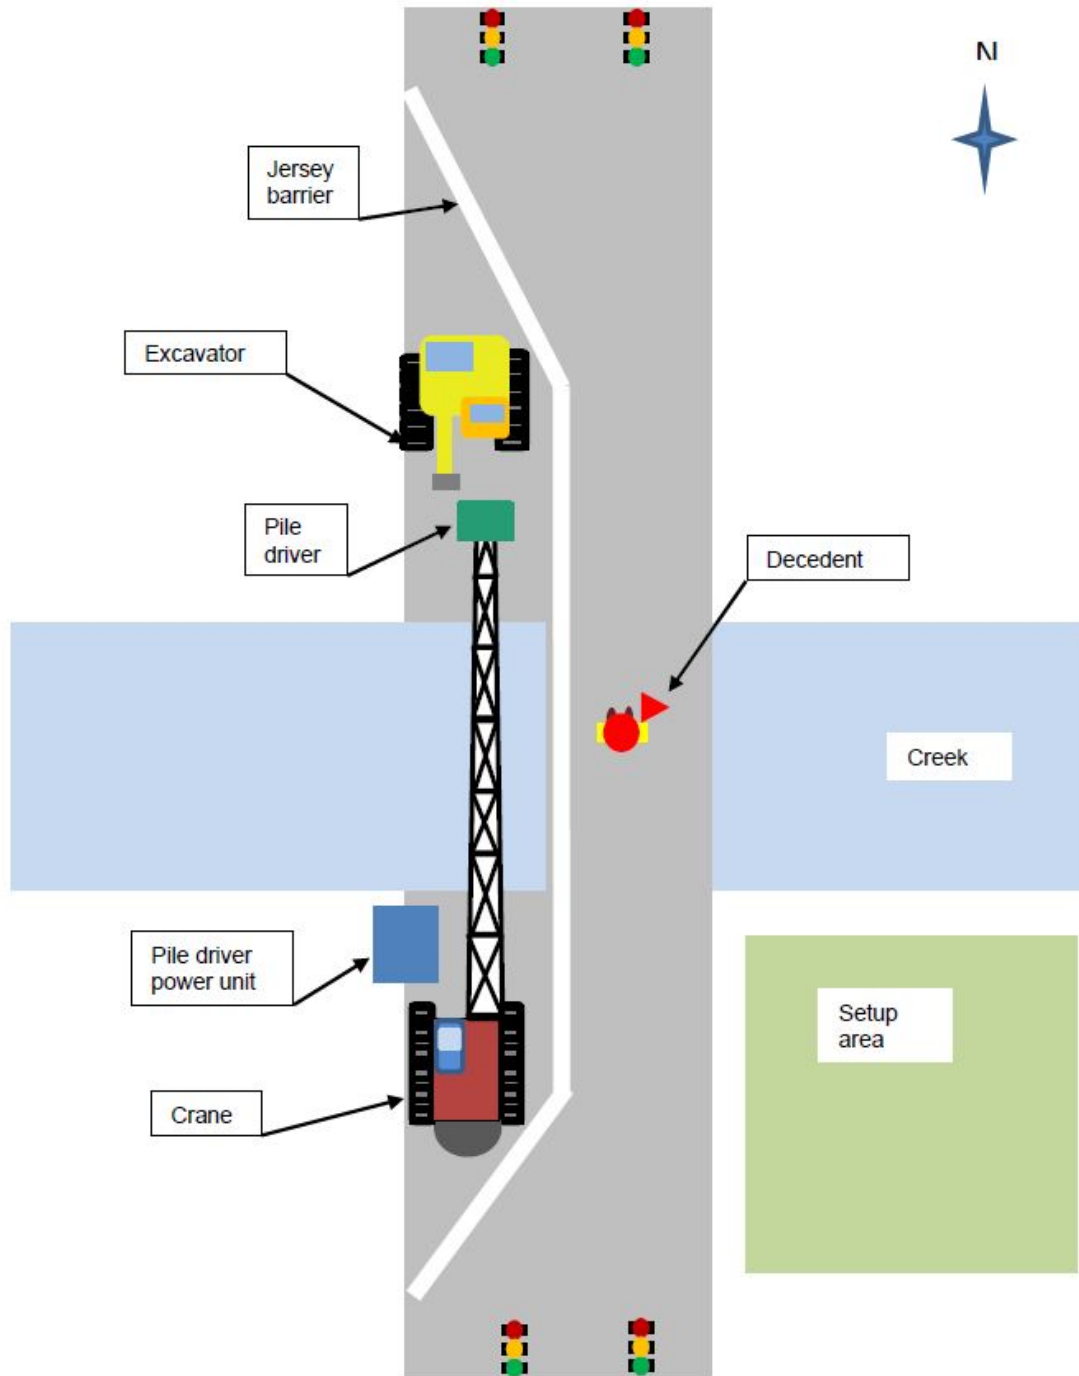
Figure 2. Incident site sketch showing locations of the decedent and the pile driving operation.

Recommendation #2: Employers should ensure that all workers are protected from being struck by the load of the crane during pile driving.

When replacing infrastructure, one major challenge is the tight work zones. The crane swing radius in this case extended beyond the actual width of the bridge. The decedent who was directing traffic in the middle of the bridge was exposed to the fatal struck-by hazard. Employers should consider using two flaggers, one at each end of the construction zone, to ensure that flaggers can work safely outside the fall zone.

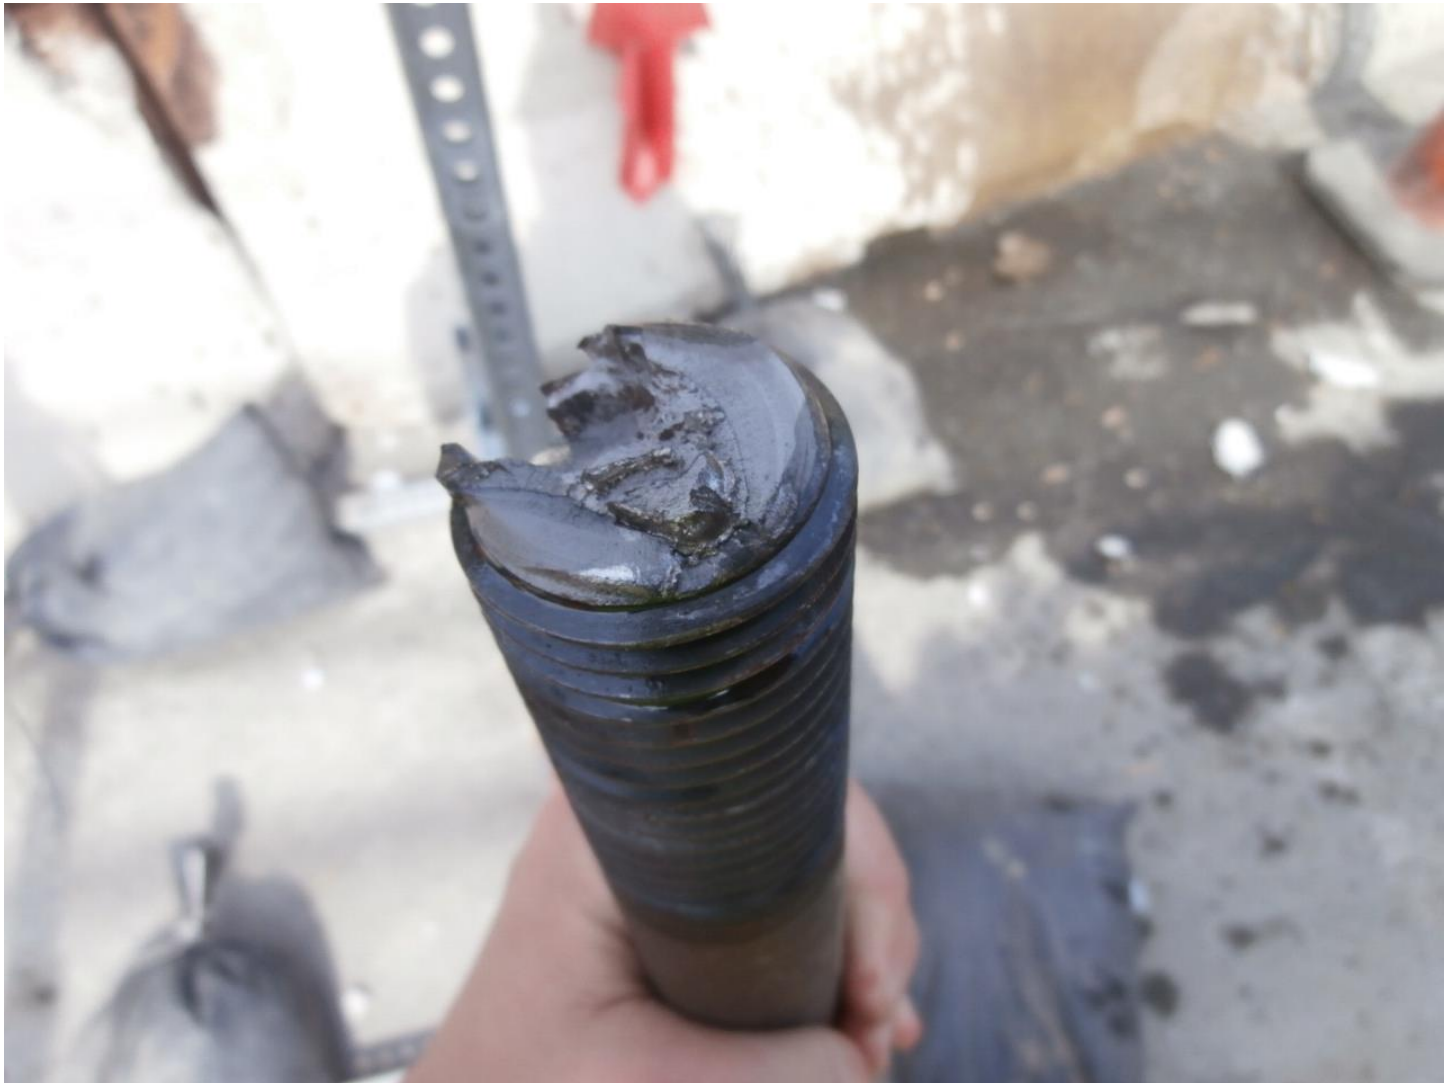
Two broken bolts were found at the site after the incident. Each bolt had metal failures, leaving a portion of the threaded end in the pile driver (Photo 6). One bolt piece was found on the north side of the bridge, this was the one observed by the crew. The other piece was found on the south side of the bridge, on the debris netting. Both pieces were 1 ^{1/2} inches in diameter, and one was 11 ^{5/8} inches long, and the other was 12 ^{1/8} inches long. They were the clamp bolts that secured the fixed jaw to the gear case.

Photo 6. The clamp bolt broken from the vibratory pile driver had metal failure (photo courtesy of OSHA).

Recommendation #3: Employers should ensure that the hydraulic clamp bolts are inspected and evenly tightened to appropriate torque as specified by the manufacturer.

The manufacturer in this case required that the clamp bolts be torqued to 2800 ft-lbs (3.79 kN-m) with a torque wrench. The crew did not have a torque wrench on site, and the foreman did not know the correct torque. Employers should ensure that all clamp bolts are evenly tightened to the specified torque, and all clamp bolts are inspected at the beginning of each shift. Since vibration loosens bolts, workers should check the bolts periodically during their shifts depending on driving conditions. If one bolt breaks, all bolts must be immediately replaced since others may be damaged. Never drive piles if one or more bolts are broken.
