FATALITY ASSESSMENT AND CONTROL EVALUATION

Machine operator fatally struck by safety block ejected from mechanical power press
Case #: 16NY064

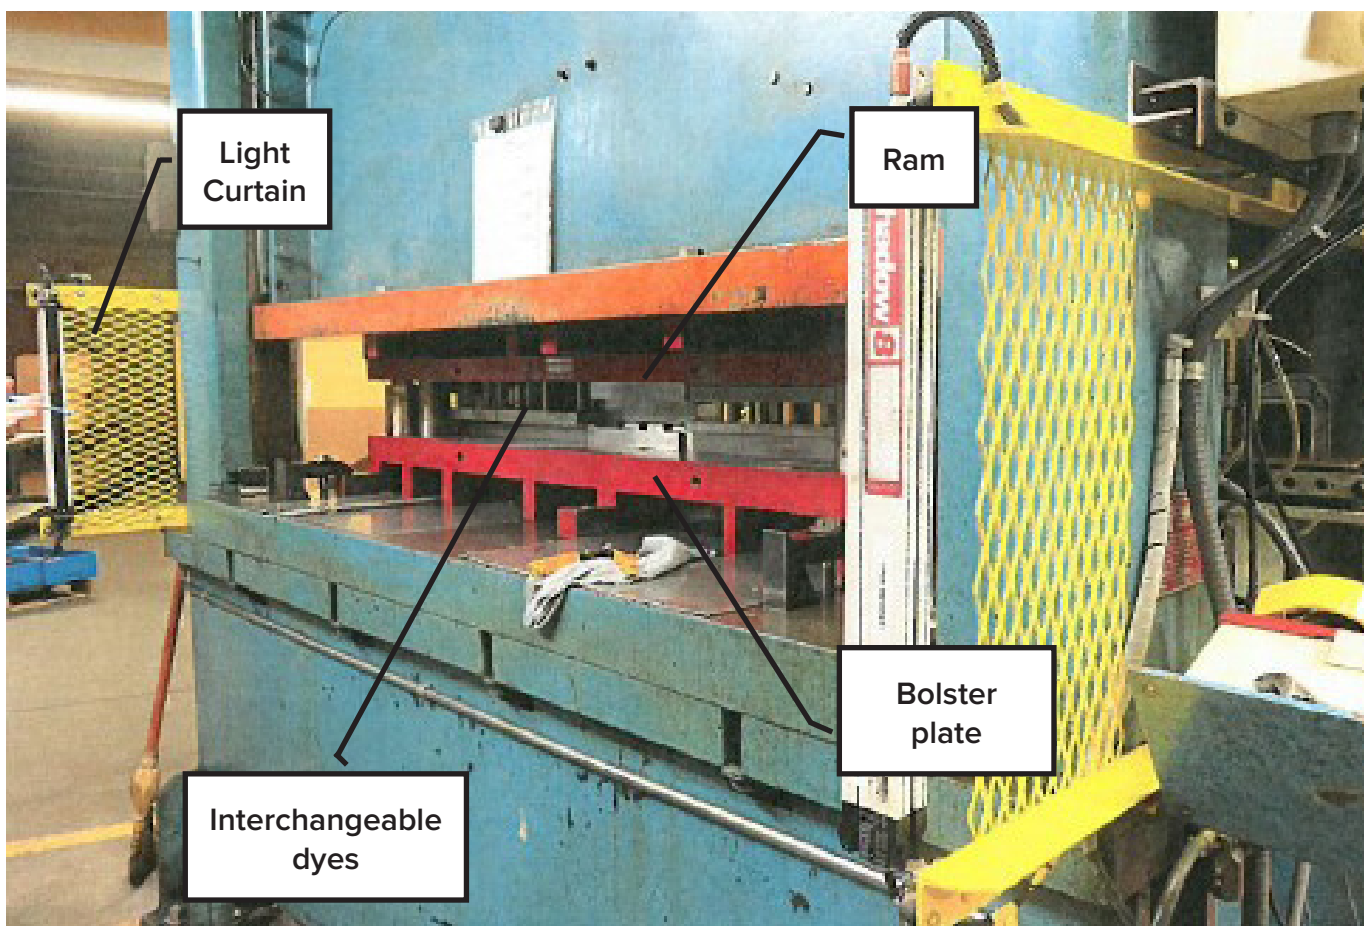
The machine involved in the incident was a 200-ton mechanical power press with a bed area that was 42 inches wide by 78 inches long (see Photo 1), which was powered by a combination of electrical and mechanical energies utilizing a flywheel. This press consisted of a stationary bolster plate (mount for die block that sits on₂

Photo 1. Mechanical Press involved in incident with light curtains (Photo courtesy of OSHA)

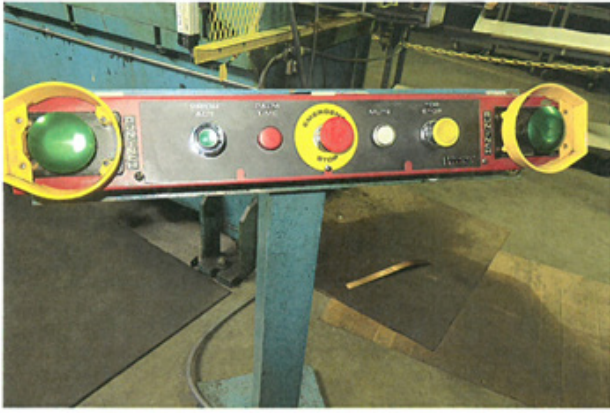
The mechanical press was outfitted with a two-button control panel and an emergency stop. The two-button control panel required the operator to press both buttons on the control panel at the same time to actuate the press. This control is a built-in safety feature intended to prevent the operator's hands from entering the point of contact when actuating the press. The two-button control panel was installed on a pedestal and connected to the press with a long cord (see Photo 2). The pedestal could be moved to locations around the press allowing operator to have the best working view and easy access to the press.

Photo 2: Pedestal-mounted two-button controller for press actuation. (Photo courtesy of OSHA)

Recommendation #4: Employers should ensure that press controls are moved to short ends of press to avoid risk of being struck by materials ejected during press operation.

Discussion: At the time of the incident, the decedent was standing by the controls in front of the long side of the press. Controls for this press are on a chord and can be maneuvered to several positions around the press. Keeping the press controls by the spool of raw material as it enters the press keeps employees out of areas where material could be more likely to be ejected from the press and allows more opportunity for guarding around the operating area. Additionally, the keypad that controls press speed and cycle type is located on the short end of the press where raw material is uncoiled and fed into the press. Keeping all points of control within the operator's reach allows the operator to control press movement through the key-operated control system as well as maintaining control of press operation through the two-button control pedestal.

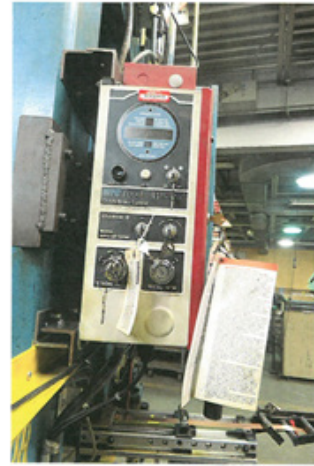
Photo 3: Key-required controller mounted to infeed side of press. (Photo courtesy of OSHA)

material was fed into the press (see Photo 3). This control box required a key to switch press operational modes from “inch,” where the ram moves in small incremental movements for die set up and test cycles, as well as a “run” mode which was for normal operation. The control box has an “off” selection, where the control box would override the dual push button control panel mounted to the pedestal.

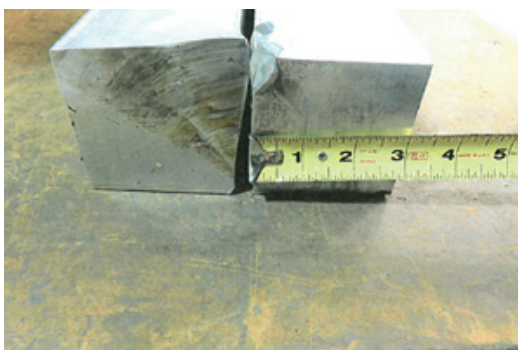
Photo 4: In-house fabricated aluminum safety blocks with deformed corners and scraped metal face. (Photo courtesy of OSHA)

Post incident examination of the ejected safety blocks revealed that block deformation was limited to corners of the 3-inchx3-inch block face, indicating that uneven pressure was exerted on the block. This was likely caused by the positions of the blocks which were not aligned with the longitudinal central axis of the ram (Photos 4 and 5). The uneven pressure exerted by the press contributed to the blocks to be forcefully ejected, striking the victim.

Recommendation #2: Employers should ensure that the selected safety blocks meet the rated capacity of the specific power presses.

Discussion: Blocks can be purchased to support the full static weight of the 200-ton press ram and should be engineered to have sufficient contact area for ram support. Depending on the anticipated load of the press, up to four safety blocks may be required to withstand the static load of the ram.

The employer in this case did not consult with the press manufacturer about the appropriate specifications and requirements of the safety blocks, such as the size, height, and material strength as well as the number of the safety blocks needed for this press.

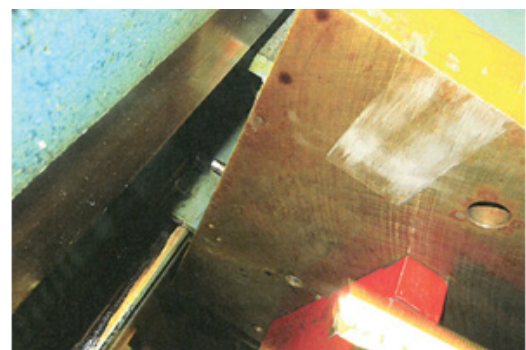
Photo 5: Picture of mechanical press ram indicating where safety block had been placed. (Photo courtesy of OSHA)

Discussion: By placing safety blocks centered along the central axis of the press, any difference in pressure in the ram would be prevented. In this case the safety blocks were placed on one long side of the ram closest to the operator, so when the press was actuated, the force of the ram created a pressure differential between the two halves of the press, causing one side of the ram to press unevenly, applying shear forces to the safety blocks that ejected the safety blocks from the press.

Recommendation #3: Employers should place safety blocks centered along middle length of press when servicing.

Another option for employers would be to use safety blocks on all four corners of the press to ensure that the pressure is distributed evenly across the ram. This would prevent any uneven depression that would unevenly deform safety blocks or force them out from between the ram and bolster.

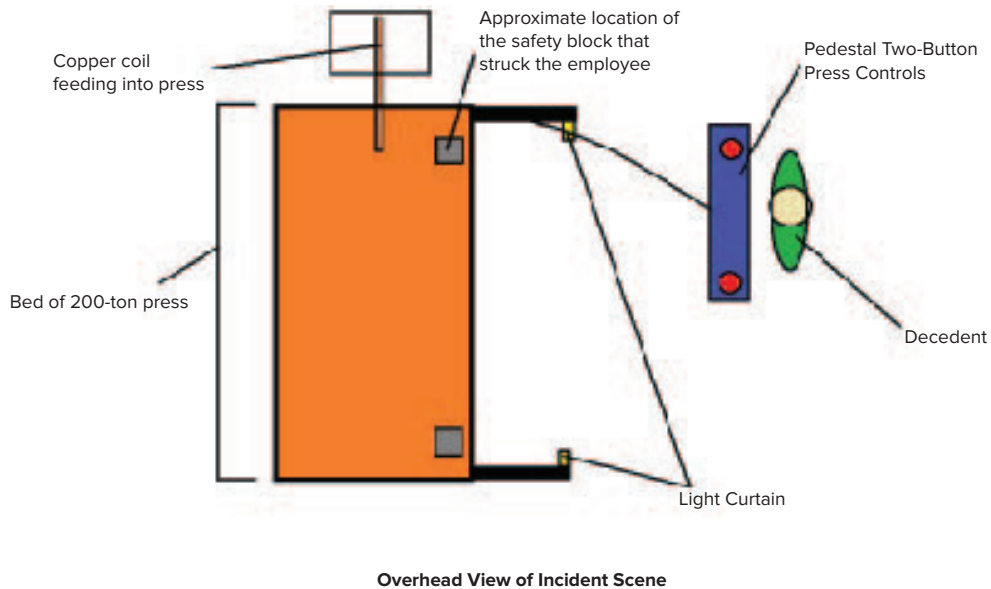
According to OSHA, the decedent had been told to place the safety blocks towards the middle of the press by personnel with more experience, but this was not included in any written program. The light curtain did not stop the press from cycling because the operator was outside its 18 inch-detection perimeter around the press.

Figure 1. Overhead view of the incident scene

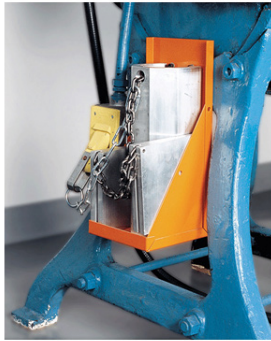
Photo 1: Example of safety blocks with interlock devices. (Photo from EHSToday.com)

Recommendation #1: Employers should ensure that interlock devices are used in conjunction with safety blocks when working with mechanical power presses.

Several safety blocks are available on the market that include interlocks to avoid mechanical press cycling when the safety blocks are deployed. Safety blocks for mechanical presses are typically metal cylinders composed of an aluminum alloy with attached plugs on chains for interlock mechanisms (Photo 1). These plugs form the interlock system which when placed in-line with the press's circuitry, prevent press actuation when the safety blocks are not plugged in.
