**REPORT#:** 20NY030

## Town highway department mechanic crushed when truck fell off jack stand —New York

## State **FACE** Program

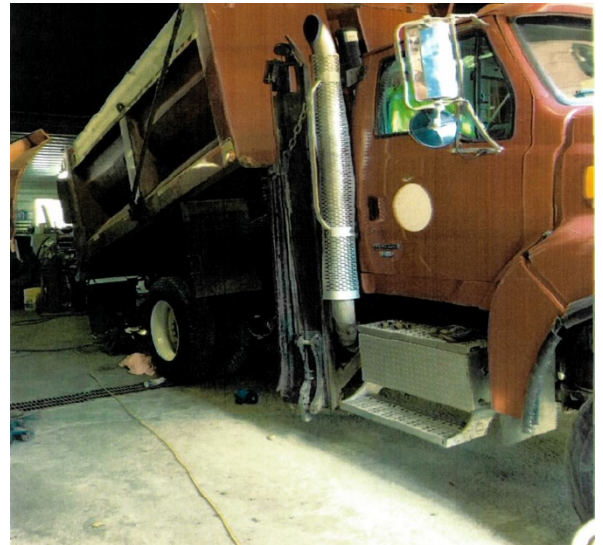
*Photo 1: Truck involved in incident with right rear wheel missing (photo courtesy of PESH).*

On October 21, 2020, a mechanic for a town highway department was fatally injured around 8:30 AM while he was in the process of changing air brakes on a truck in the town highway department garage (Photo 1). The New York State Fatality Assessment and Control Evaluation (NY FACE) staff learned of the incident from news media reports and contacted the employer to initiate an investigation. Additionally, NY FACE contacted the Public Employee Safety and Health Bureau (PESH) in the New York State Department of Labor (NYS DOL) to request information regarding the investigation. PESH is the regulatory body for NYS public employee safety, and initially investigated the case after the incident. NY FACE staff discussed the case with PESH to gather specific details of the incident.

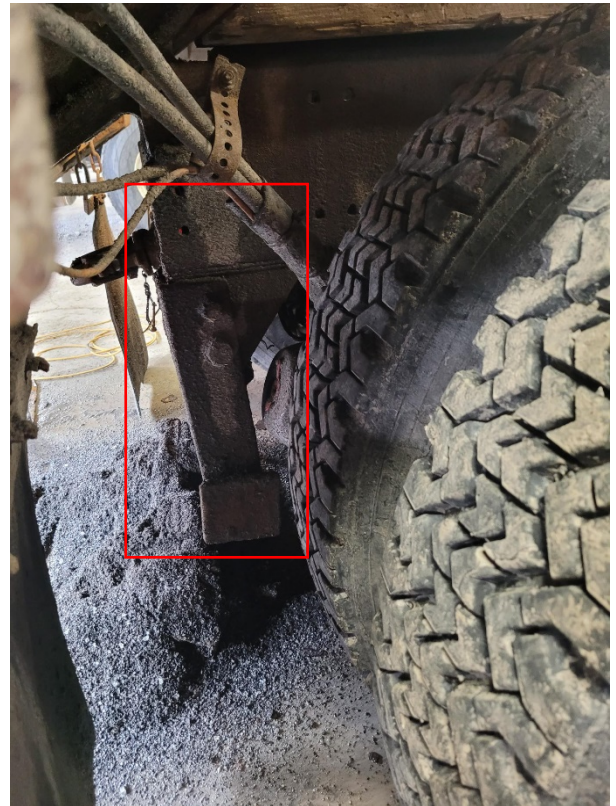
*Photo 2: Chipper bar behind right rear tires of truck*

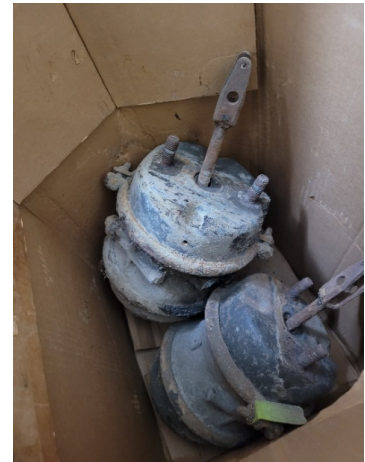
The day of the incident, the decedent was working on changing out the passenger side rear axle air brake canister on Truck 22 in Bay 1 (Photo 3). The passenger side dual rear axial wheels had been removed from the wheel hub to better access the air brake system. The wheel hub was supported by the 12-ton jack stand seen in photo 7. According to eyewitness statements and PESH investigation, the 22-ton pneumatic jack was not being used in conjunction with the 12-ton jack stand on the day of the incident. Additionally, there was no cribbing under the truck, no wheel chocks were being used, the keys to the truck had been left in the truck's ignition, and the truck had been left in neutral. The truck's braking system, including the parking brake, was not operable because the maintenance activity the decedent was performing required releasing air from the truck's systems, which included the parking brake. The box of the truck, which was elevated and held up by its support arm, was not cribbed on the day of the incident. The box of the truck being elevated may have affected the truck's center of gravity, placing more weight on its rear wheels and the 12-ton floor jack. The floor of Bay 1 where the decedent had been working had a floor gradient of approximately 3-4 degrees sloping towards a central floor drain, which was an approximate slope angle based on the photo 6, supplied by PESH for this investigation.

*Photo 3: Air brake canisters or 'air cans' involved in routine maintenance of truck braking system*

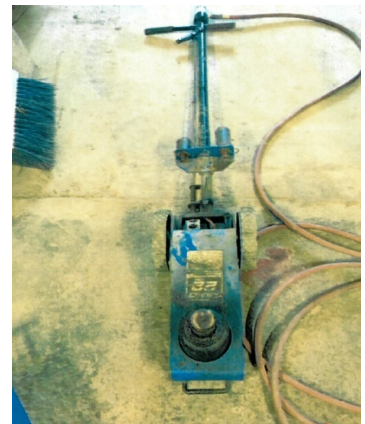
*Photo 4: 22-ton pneumatic jack typically used to support truck during air brake maintenance (photo courtesy of PESH)*

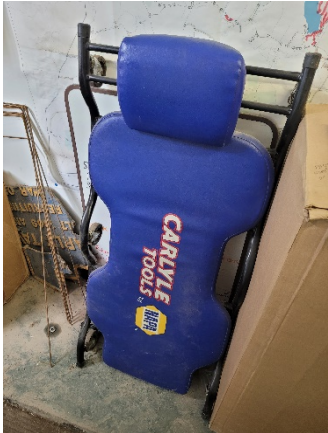
The decedent was performing the work lying on his back on a mechanics creeper under the truck. The mechanics creeper is a low-lying rolling dolly meant to be laid down on by mechanics for servicing the underside of vehicles without needing the mechanic to lie directly on the ground (Photo 5). To work on the air brake canisters, the decedent was required to position his body underneath the chipper bar behind the right rear wheel hub (Photo 2). The creeper's height off the ground was approximately 3 inches, and the chipper bar was positioned about 12 inches off the ground, which allowed for approximately 9 inches of clearance between the chipper bar and the mechanics creeper for the decedent to fit between in order to work on the passenger side rear axle air brake canister.

*Photo 5: Mechanics Creeper used by decedent for maintenance under Truck 22*

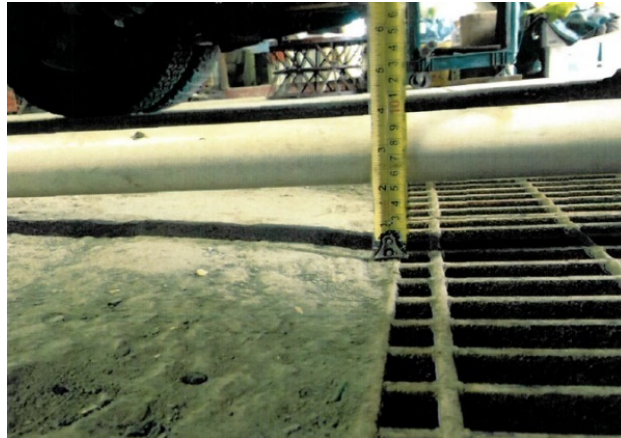
*Photo 6: Floor gradient at Bay 1 central drain over 10-foot span (phot courtesy of PESH)*

environment where the work will take place. A JHA would address the floor gradient as a safety risk and discuss the potential severity of injury, the likelihood of injury, and suggest methods to help mitigate the risk.

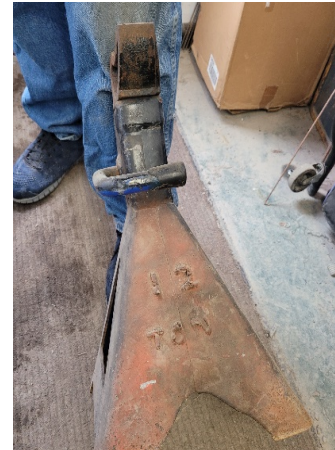
*Photo 7: Floor jack stand involved in incident*

Discussion: During the PESH investigation, it was determined that the decedent did not use any wheel chocks or additional cribbing under the vehicle to prevent truck movement or the potential failure of the 12-ton jack stand. Employers should ensure that employees use wheel chocks and cribbing to prevent truck rolling or falling. Using chocks and cribbing in addition to the 12-ton jack stand would have prevented the truck from rolling, which is ultimately what caused the incident. Wheel chocks and cribbing use should be included in an Employer's LOTO procedure for maintenance items that require personnel to work under trucks.
