STATE OF NEW YORK DEPARTMENT OF HEALTH

FATALITY ASSESSMENT AND CONTROL EVALUATION

Day Laborer at Boat Dock Drowns After Falling Into River

Case Report: 08NY021

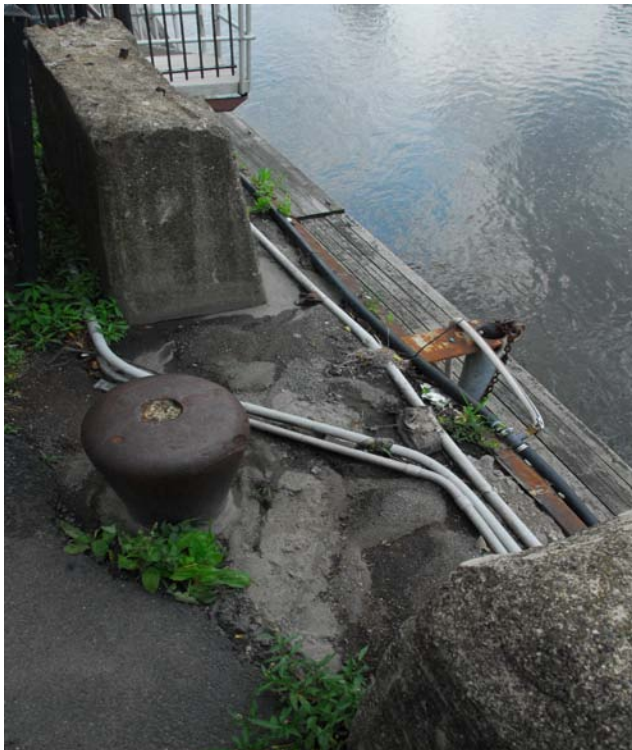
While the victim and his friend worked at the storage area, the dockmaster and another worker were at the dockmaster station by the river preparing to set up the floating docks. Around mid-morning, the day laborer and the victim received a phone call from the worker who asked them to come to the station to assist him and the dockmaster in placing the docks in the river. The seawall is a concrete vertical wall that extends approximately twelve feet above the mean water surface. On the land side of the seawall are parking lots used by boaters, employees and patrons of local businesses, and the general public. A three-foot high concrete barrier sits on top of the seawall at the surface of the parking lots. There are openings at 50 foot intervals along the barrier that provide access to steel mooring cleats. Each of these openings is about 5 feet wide.

After arriving at the docks, the victim and the day laborer were standing in the parking lot near the seawall awaiting instructions when the victim reportedly tripped or stumbled and then fell into the river through an opening in the barrier (Photo 1). Once in the water, the victim remained visible to his co-workers for only a few seconds. The workers immediately called 911. One of the workers dove in to save the victim, but could not locate him. None of the workers were wearing personal flotation devices (PFDs) and there were no life-rings at the scene. The State police, paramedics, fire department and the New York State Police (NYSP) scuba diving team responded to the scene. The victim was recovered at 1:35 PM. He was transported to a local hospital where he was pronounced dead.

Photo 1. The area where the victim fell. The floating docks shown here were placed in the water after the incident.

Recommendation #3: *Employers should provide a standard height railing or other means of fall protection where fall hazards exist.*

Discussion: The Occupational Safety and Health Administration's (OSHA) standard for Maritime Terminals (29CFR1917) stipulates that guardrails be provided at locations where employees are exposed to floor openings or waterside edges which present a fall hazard of more than four feet or into the water. The top surface of the guardrail is required to be 42 ± 2 inches high (36 inches high if installed prior to October 3, 1983). In this incident, having a guardrail or other means of fall protection in place at the opening in the barrier wall may have prevented the victim from falling into the water.
