INCIDENT HIGHLIGHTS

REPORT#: 20NY025

REPORT DATE: 8/5/22

Farm Youth Killed When Caught in Sweep Auger Inside a Silo at Family Farm

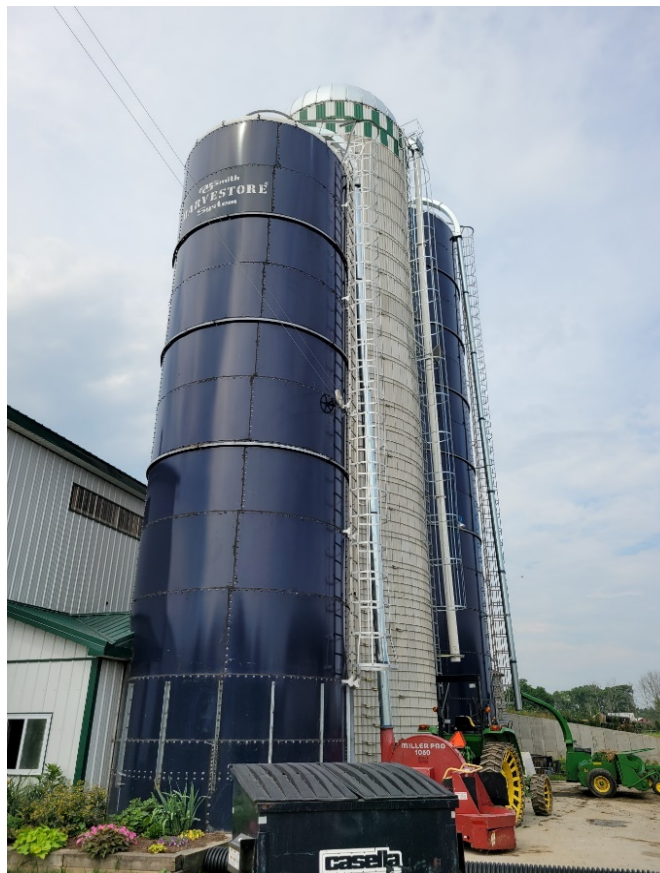
Photo 1. An 11-year-old farm youth was fatally injured by a sweep auger inside the silo that is in the foreground.

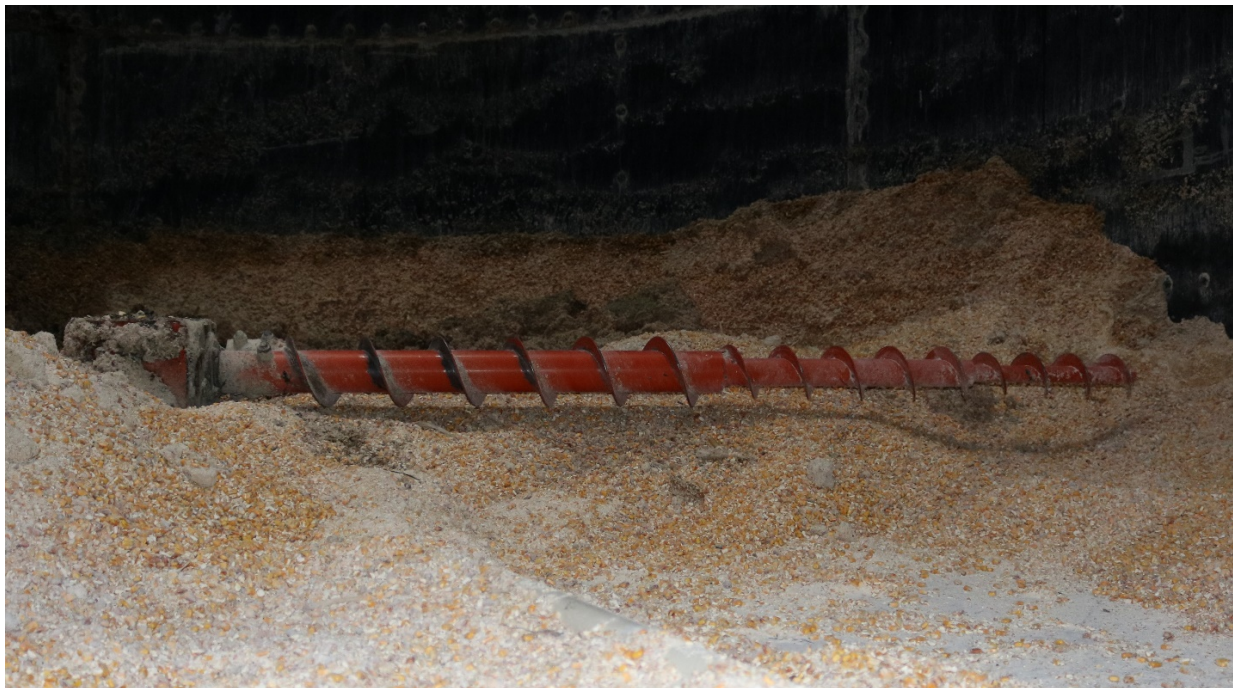
The sweep auger, which is mounted 8 inches above the silo floor and not guarded, is approximately 56 inches long. The diameter of the sweep auger tapers from 5 inches at the gearbox end to 3 inches at the periphery with approximately 10-12 inches of clearance to the silo wall (Photo 3). To move the stored material towards the hopper, the sweep auger rotates around its center shaft and circles the silo circumference counter clockwise. The sweep auger was observed circling the silo floor at a slow speed. The exact speed was not available in the silo manual. According to the father, there are protruding objects on the sweep auger. The investigators were not able to get inside the silo to examine the number, shape, and location of the protruding objects on the sweep auger.

Photo 3. The unguarded sweep auger was mounted in the gearbox 8 inches above the silo floor (Courtesy of NYCAMH/NEC).

Discussion: During the course of the investigation, it was determined that the decedent was likely caught in the auger from his pant leg causing the fatal entanglement. This particular sweep auger has protruding objects on it, which likely increase workers' risk for entanglement. Farm owners should ensure that no ones' clothing and hair are loose or long enough to get caught in rotating or revolving pieces of machinery.

Discussion: The silo unloader in this case was not equipped with technologies that would prevent accidental contact with the energized sweep auger. Many modern commercially available unloaders utilize guards around the top, rear, and tip of the sweep auger to prevent a worker from contacting the energized auger accidentally.

Sweep augers can also be outfitted with Sweep Auger Safety Handles, or SASHs. These devices create distance between the worker and the sweep auger, allowing the worker to safely manipulate a sweep auger without having to touch the actual auger or any guarding attached to the auger. These handles can be equipped with electronic switches mounted to a lever that the worker pulls down in order to actuate the auger, but also stops the auger if the lever becomes disengaged. This technology is like dead-man switches on lawnmowers, which stop the lawnmower if the user releases the lever mounted to the handle of the mower.

There are also unloaders that come with zero clearance sweep augers. Zero-clearance sweep augers are augers that do not have a substantial gap between the floor and walls of the silo and the auger, allowing the sweep auger to remove most if not all grain from a silo floor. Not only does this prevent workers from having to enter a silo while the sweep auger is engaged, but it increases efficiency by not having to rely on manual sweeping. There are scenarios where the type of grain being stored or the design of the silo and unloader does not allow for a zero-clearance sweep auger, but it should be included as a reasonable alternative to elevated sweep augers.

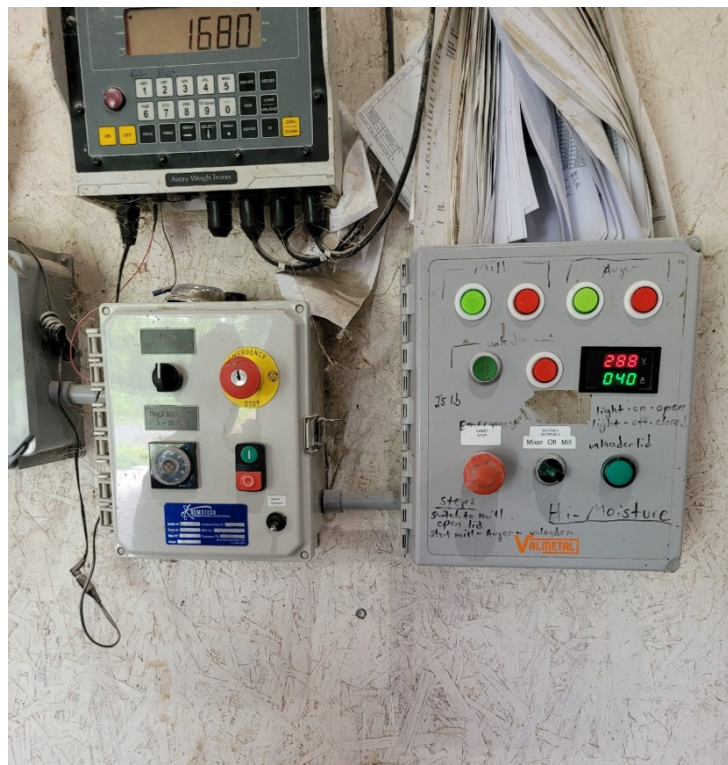
The controls and emergency shutoff devices for the unloader were located on a nearby wall, approximately 20 feet away from the drive unit (Photo 4). The manufacturer required disconnecting and locking out of the power at main disconnect before working on or near the unloader. The following warnings and requirements are in the owner’s manual: “Lock out power at main disconnect before working near equipment”, “When in operation, no one is permitted in the silo or within falling distance from all moving parts”, and “Do not allow anyone near the machine before or while the unloader is running” (Photo 5).

Photo 4. Unloader controls and emergency shutoff devices.

Recommendation #1: Farm owners should ensure that no one enters a silo unless the power to the sweep auger is turned off and locked out.

Discussion: Many fatalities, amputations, and other serious injuries have resulted from workers entering silos or grain bins without deenergizing sweep augers. Most often, these occur when a worker's clothing, shoestrings, or body parts become entangled in the rotating screw of the auger. The silo floor in this case was covered with uneven corn, the lighting was inadequate inside the silo, and there were protruding objects on the sweep auger. All of these subject workers to slip and fall hazards and further increase their risk of being caught and entangled by the rotating sweep auger. The manufacturer in this case specifically requires users to disconnect and lockout the power at the main disconnect before entering the silo.

Farm owners should ensure that all machines including the sweep auger inside a silo are deenergized, locked, and tagged before allowing anyone to enter the silo to work. In this scenario, the reason for allowing the decedent to enter the silo without turning the unloader off was to allow the exit auger, which is under the silo floor, to transport the corn out. This practice could be safely augmented by first turning off the unloader. A worker only enters the silo to sweep after the unloader is turned off. Once corn is swept to the center of the silo, the worker should exit the silo to turn the power back on so that the exit auger can transport the corn out. Technologies described in Recommendation #2 can also be utilized. Some of these technologies allow workers to remove grain safely without having to enter the silo or use equipment which are less hazardous than sweep auger.

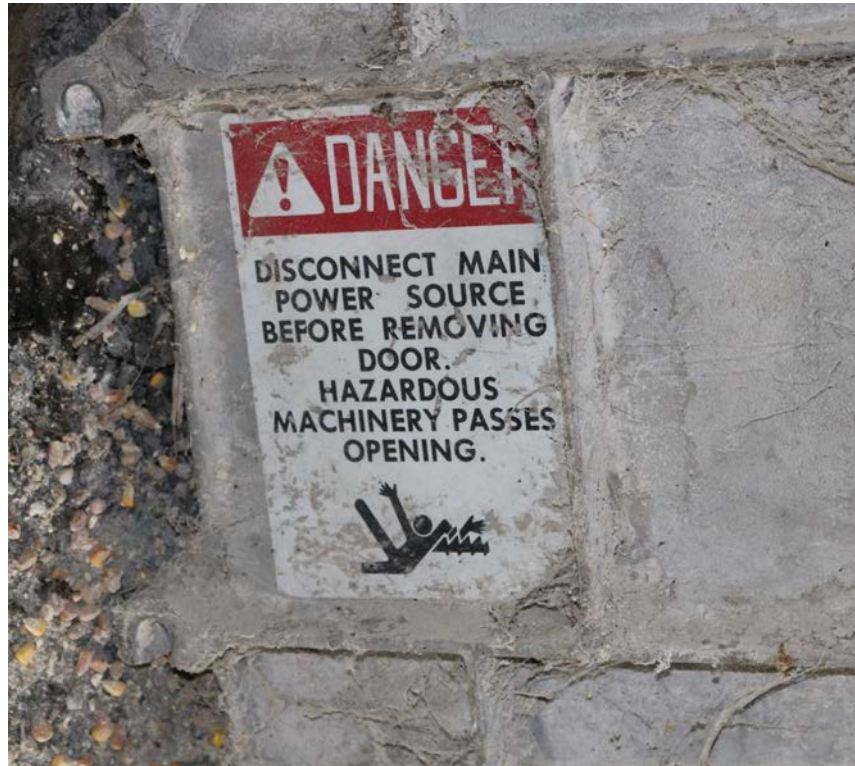
Photo 5. The warning sign on the silo hatch door requires that all operators disconnect the main power source before working near the unloader (Courtesy of NYCAMH/NEC).

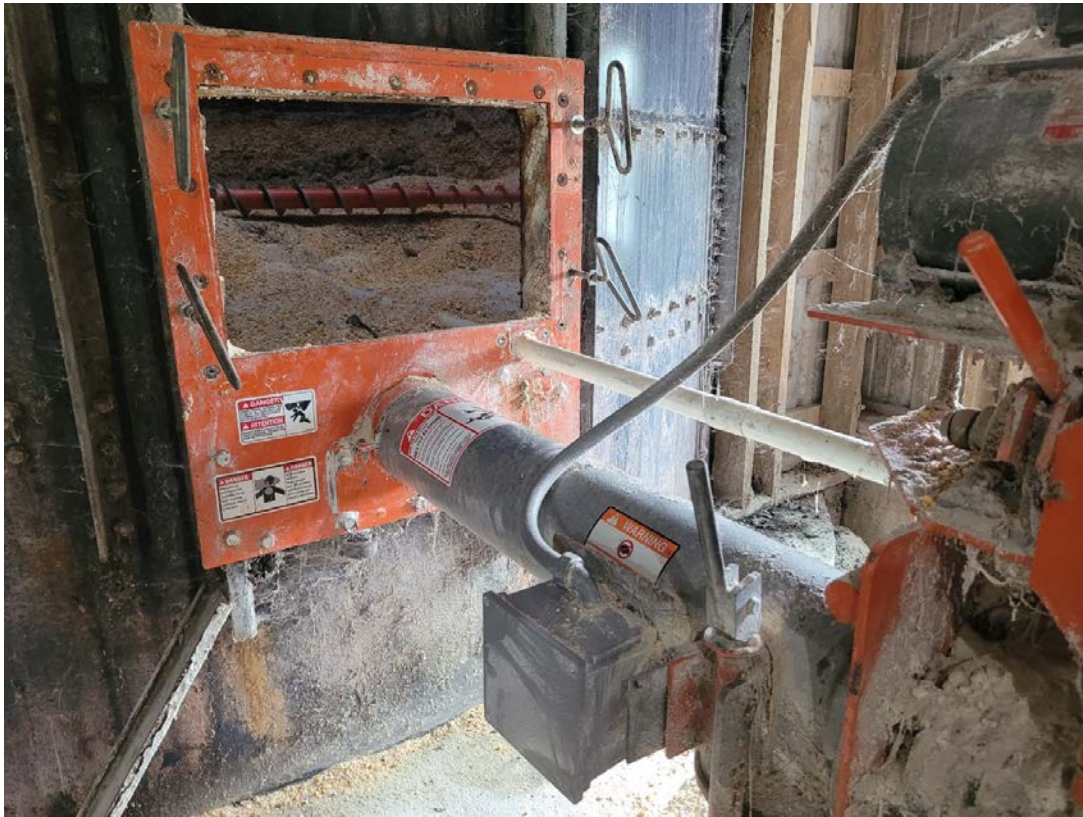
Manual cleaning of corn left on the silo floor is a routine task that has been done at this farm every year. Entry to the silo is through an access door located at the base of the silo. The access door/opening is 15.5 inches in height, 24 inches in width, and 36 inches off the ground (Photo 6). The father did not have a gas monitor to test the silo air. He used a silo blower to ventilate the silo before entry. While inside, he never turned off the power to the unloader since the sweep auger appeared circling the silo in a slow speed, and he needed the exit auger to transport corn out. He worked alone most of the time, and it was inconvenient, difficult, and time consuming to go in and out through the access door to turn the power on and off.

Photo 6. Access door in the base of the silo.

Recommendation #4: Farm owners should provide adequate artificial light source to illuminate silo interior.

Discussion: In this case, the silo interior was illuminated by only a small amount of natural light that entered through the roof fill door and the access door/opening in the base of the silo. The incident occurred in a midsummer evening approximately 9:00 p.m. when the last remaining natural light was diminishing. Poor visibility caused by inadequate lighting could have contributed to the fatal entanglement. Farm owners should provide artificial lighting to ensure that the work can be safely done inside a silo when natural light does not provide good visibility.
